SIB 66 29 19

2020-11-19

TOP VIEW CAMERA: IMAGE IS MISALIGNED

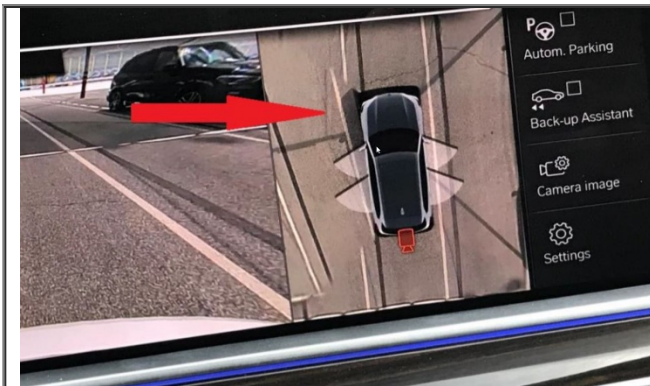
The top view image of the vehicle is misaligned when observed in the Control Information Display (CID). When the vehicle is parked in a parking spot with line markings, it is clearly noticed in the CID that the lines are not parallel to the side of the vehicle. This may be noticed on either the driver side, passenger side or both.

The arrow identifies the line which is shown as not parallel or straight alongside the vehicle.

Side view camera loose fitment in the exterior mirror bracket, causing changes to the top view image.

Reposition the camera in the exterior side view mirror with felt tape and / or software update with ISTA 4.26.3x or higher. Target Integration level (I-level) of S15A/S18A-20-11-500 or higher.
