SIM 52 01 19

NOISE DURING FORWARD / BACK SEAT ADJUSTMENT OVER THE ENTIRE LENGTH OF TRAVEL

This Service Information Bulletin (Revision 1) replaces SI M52 01 9 dated **September 2019**.

F54 MINI Clubman	F60 MINI Countryman
Vehicles produced from April 7, 2019 to June 28, 2019

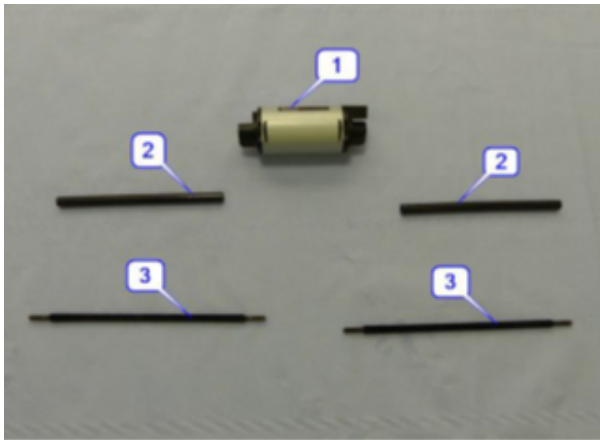
This picture shows the disassembled motor and drive shafts.

1. Motor
2. Outer housing of the cable

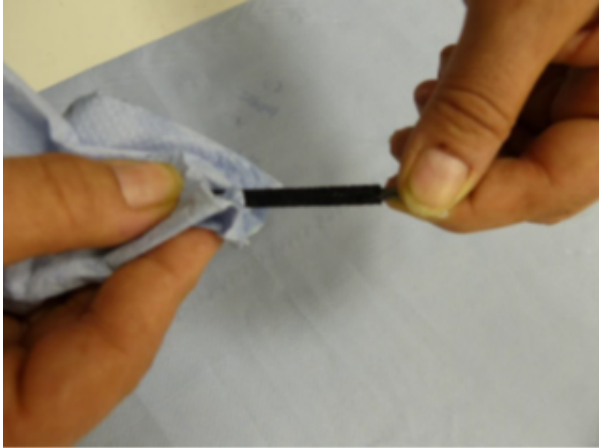
3. Flexible drive shafts

Lubricate the flexible drive shaft over its entire length using a lint-free cloth and P/N 83 23 9 407 810 Grease (NBU 12K)
