## Warranty Extension: 2012-15 Civic Hybrid IMA Motor Power Inverter (MPI)

### AFFECTED VEHICLES

Year	Model	Trim Level	VIN Range
2012-15	Civic Hybrid	ALL	Check the iN VIN status for eligibility.

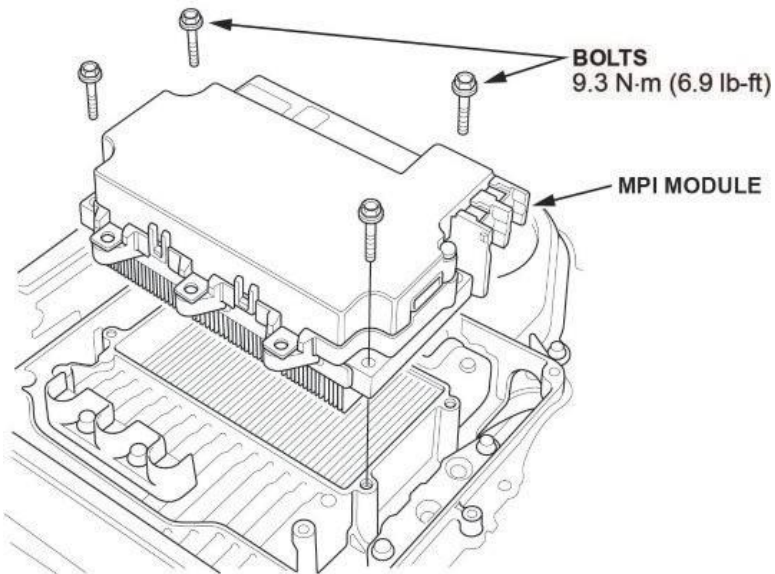
The Motor Power Inverter (MPI), also known as the Intelligent Inverter Unit (IIU), may fail over time due to a defective solder joint. This failure may result in one or more of the following DTC(s):

Do an all-DTC check and replace the MPI if any of the DTC(s) listed under INSPECTION PROCEDURE are stored.

23. Remove the MPI module and install the new MPI module.
