## STAR ONLINE PUBLICATION

**Case Number:** S2008000171

**Symptom/Vehicle Issue:** HVAC Blower Motor Operates Intermittently Or Changes Speeds

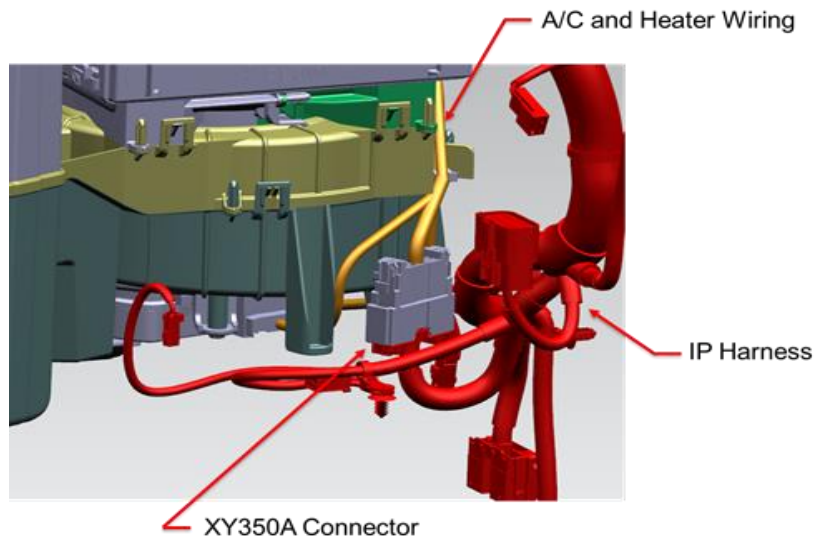
Fig 1

**Customer Complaint/ Technician Observation:** Customers complaint is that the blower motor intermittently slows or momentarily stops blowing without any mode change inputs. Technician observed DTC's B10EB-19 (Blower Power Module - Overcurrent) or B10C8-15 (Blower Motor Control Feedback Circuit – Circuit Short to Battery or Open).

**Repair Procedure:** Inspect the XY350A black connector to ensure the connector is securely fastened. If connector was not securely connected, disconnect and review for any bent pins or spread terminals. If no pin(s) are bent or terminal(s) spread, then re-secure the connector. If pin(s) are bent, adjust or replace the harness as needed, if terminals are required use terminal repair kit to repair 68496388AA, Fig 1, 2.

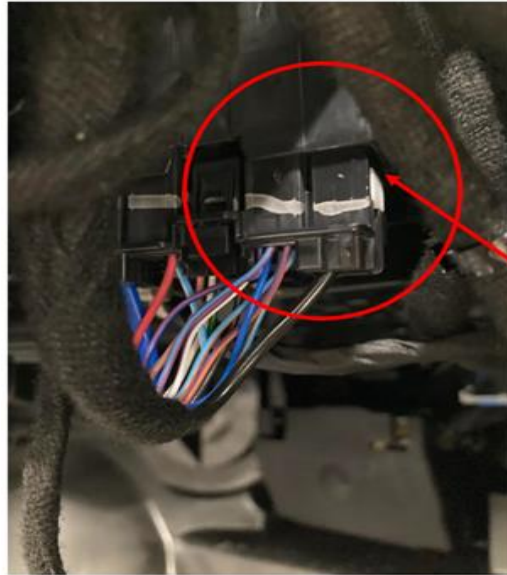
Fig 2

XY350A Connector  
Partially Connected
