STAR ONLINE PUBLICATION

Case Number: S1708000262 REV A.

Symptom/Vehicle Issue: Check Engine Lamp Is On, Intermittent Module CAN Private Or LIN BUS Codes

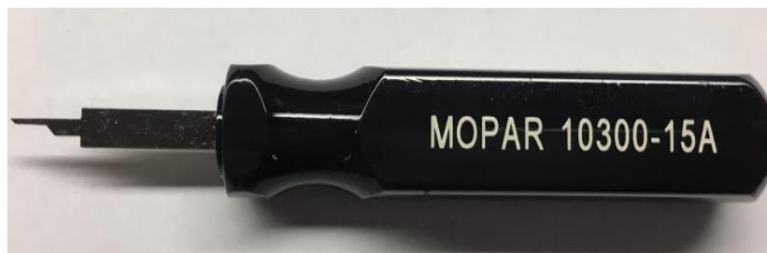
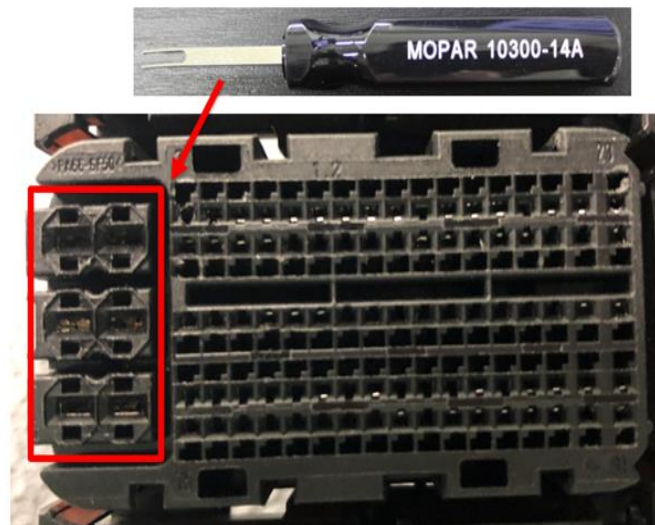
Fig 2

The larger double locking tab terminal requires Tool 10300-14A

These instructions focus on removing the smaller single lock tab terminal from the GA 2.0L PCM connectors using Mopar terminal tool number 10300-15A. For the double lock tab, refer to figure 2.
