STAR ONLINE PUBLICATION

Case Number: S2008000183

Symptom/Vehicle Issue: The Stop/Start (ESS) Off Switch Does Not Illuminate When Pressed

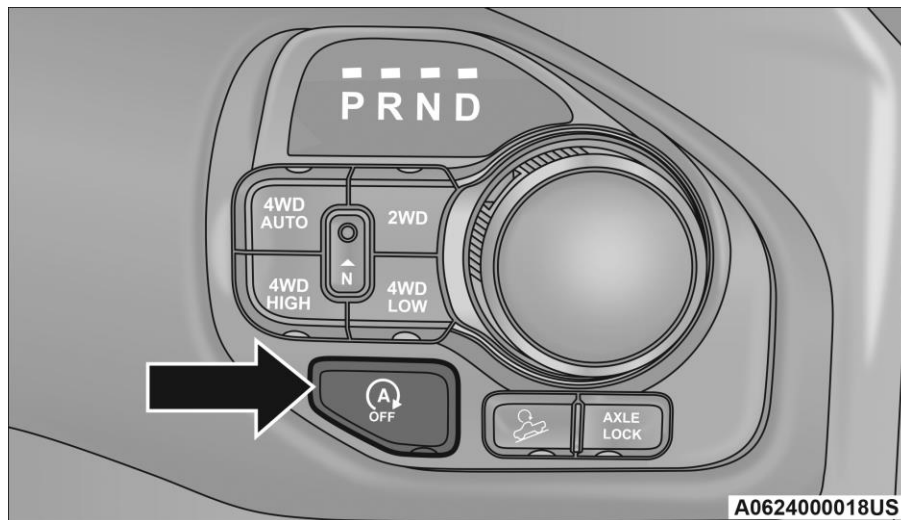
Discussion: The customer may notice that the Stop/Start (ESS) Switch located underneath the rotary shifter does not illuminate when pressed. However, the message appears in the Cluster that Stop/Start has been disabled.

PCM or rotary switch bank replacement WILL NOT remedy this concern. Only 5.7L BSG(E-Torque) equipped vehicles are effected.

Engineering is aware of this issue and is currently developing a service resolution. A PCM TSB software update is expected by the beginning of January 2021.
