NUMBER: 08-100-20

Incorrect Starter Motor Installed

2020 (DT) RAM 1500 Pickup

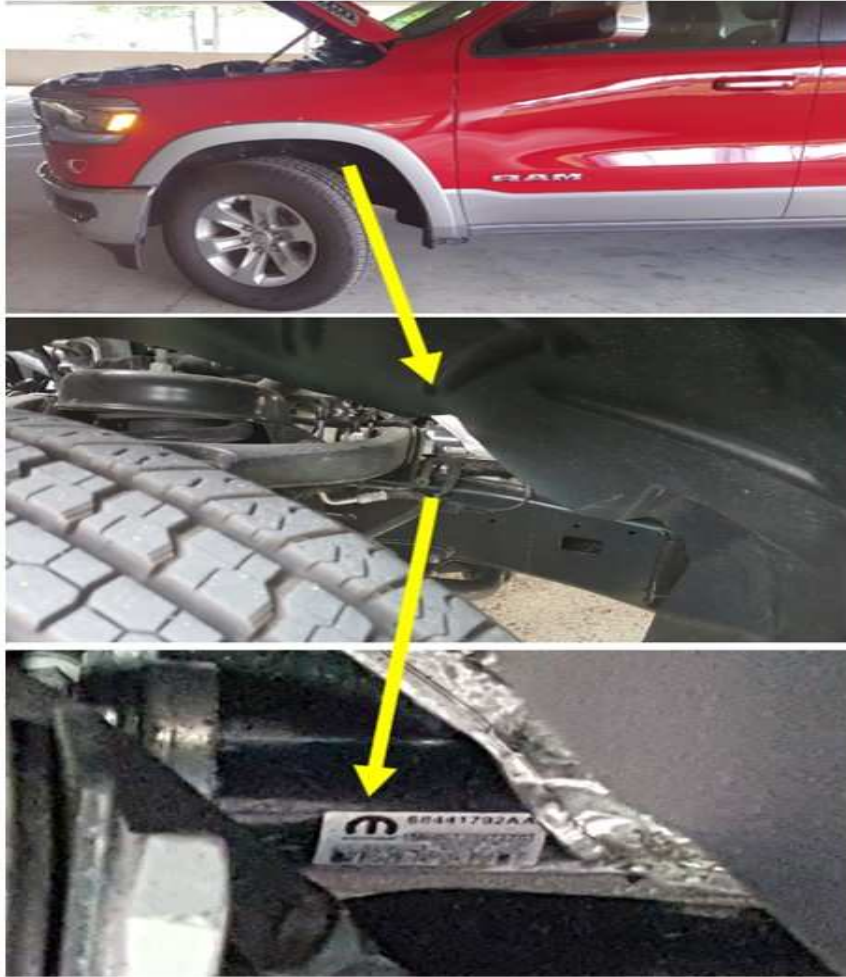
Fig. 1

For vehicles parked and on the ground perform the following inspection ([Fig. 1](#)) :

1. Turn wheels to the right.
2. Look between tire and frame.

Julian Date Code Location

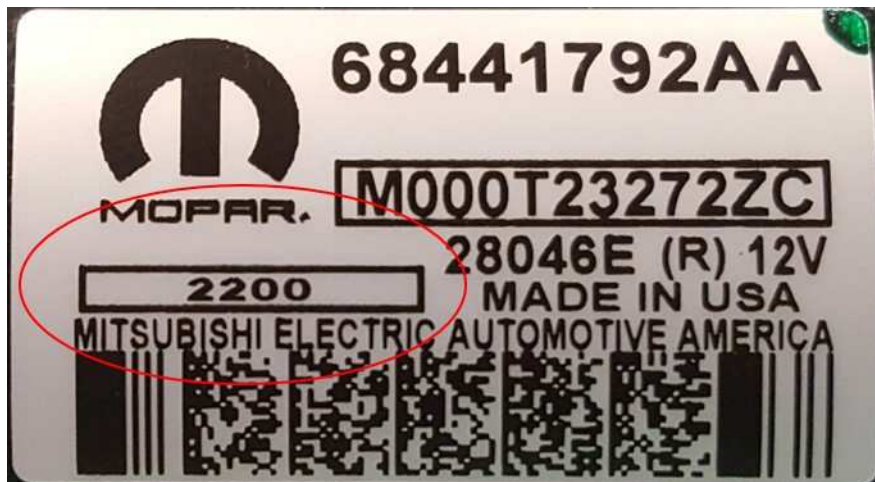
Fig. 2

3. Verify the starter motor Julian date for 2200 (Fig. 2) .
 - Is the Julian date code 2200?

Julian Date Code 2200

- YES>>> Proceed to [Step 1](#) of the Repair Procedure.
- NO>>> This Bulletin does not apply, use inspect LOP (08-75-01-98) to close the active RRT. Normal diagnosis should be performed.

1. Remove and replace the starter motor. Refer to the detailed service procedures available in DealerCONNECT> Service Library under: Service Info> 08 - Electrical / 8F - Engine Systems / Starting / 5.7L Starter / Removal and Installation.

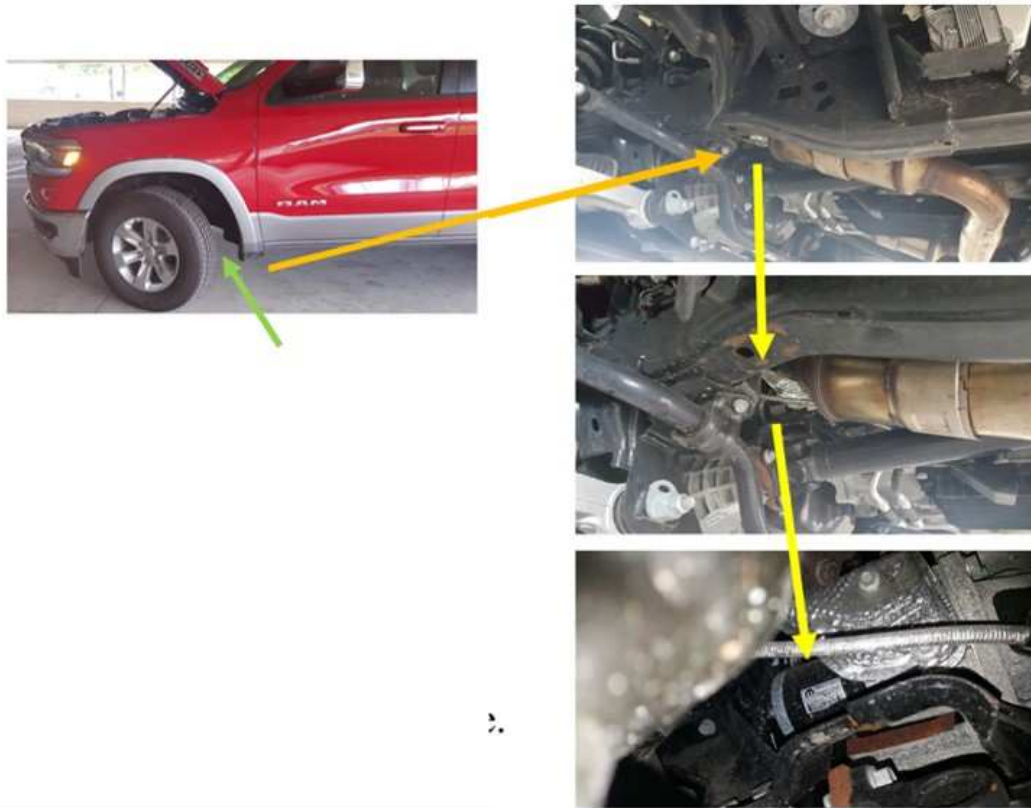
Fig. 3
Julian Date Code Location From Underneath

For vehicles on a hoist perform the following inspection (Fig. 3) :

1. Turn wheels to the right.
2. Look at the starter motor towards the engine.

3. Verify the starter motor Julian date for 2200 (Fig. 2) .
 - Is the Julian date code 2200?
 - YES>>> Proceed to [Step 1](#) of the Repair Procedure.
 - NO>>> This Bulletin does not apply, use inspect LOP (08-75-01-98) to close the active RRT. Normal diagnosis should be performed.
