SS 1034868 New Cascadia Flickering Reading Light

All New Cascadia equipped with a DR 40SI alternator, possibly other alternator options.

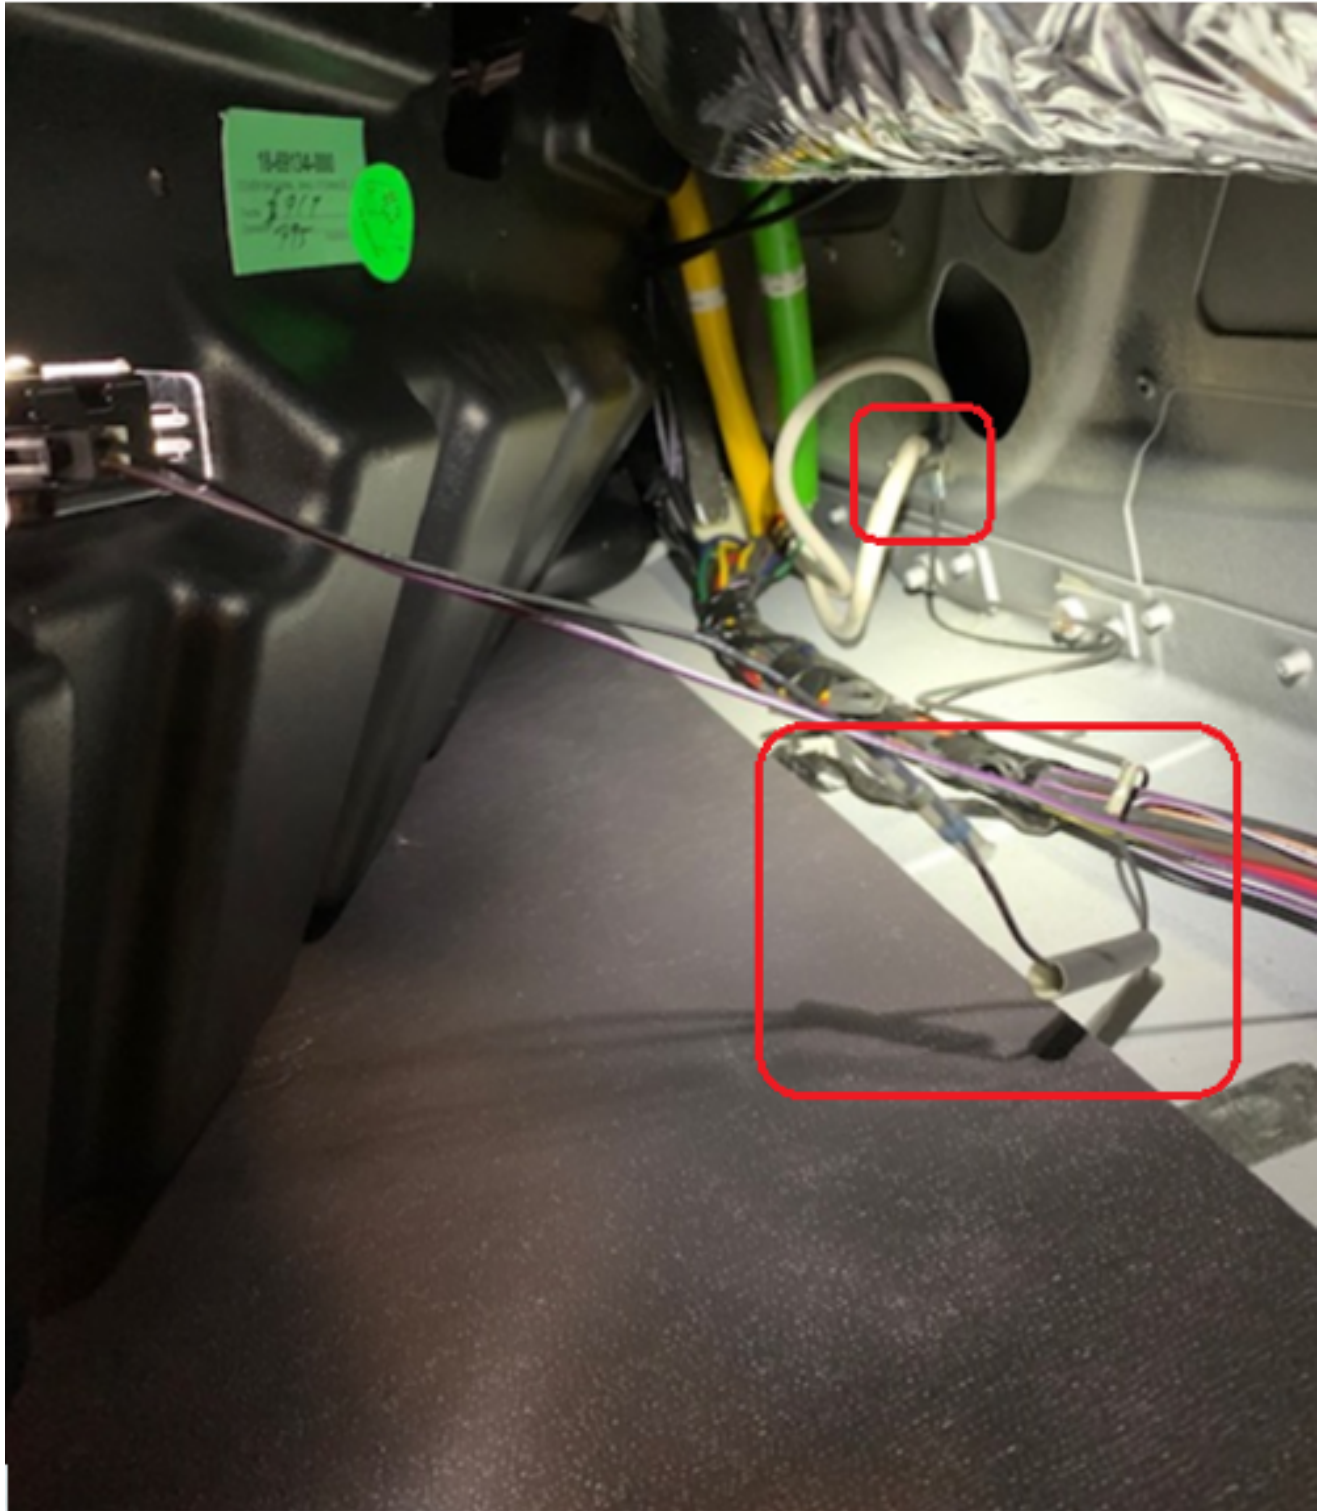
All power receptacles not populated, slight movement of the steering wheel, can result non cyclical flickering of the overhead reading light. Reports of this issue to date have only been identified in applications of DR 40SI alternators. The sensitivity of the overhead reading light LED may pick up random ripples in current to the reading light assembly. Field staff discovered that the light would stop flickering when turning on either a cargo lamp or bunk lamp. Adding a redundant ground from the cargo light to the backwall stud suppresses the flickering light.

The flickering overhead light is considered a nuisance, and can be simply eliminated by either adding an accessory to one of the power receptacles, or running an additional ground in one of the sleeper bunk lamps to suppress the ripples on the circuit. Future plans include supplier update to the reading light assembly that includes a suppressor.
