SERVICE BULLETIN

Subject: **GPS Not Charging - Possible Inverted Wires at Vehicle Connector**

2020-7

YEAR	MODEL
2018 and newer	Spyder F3 T and F3 Limited
2020 and newer	Spyder RT Series

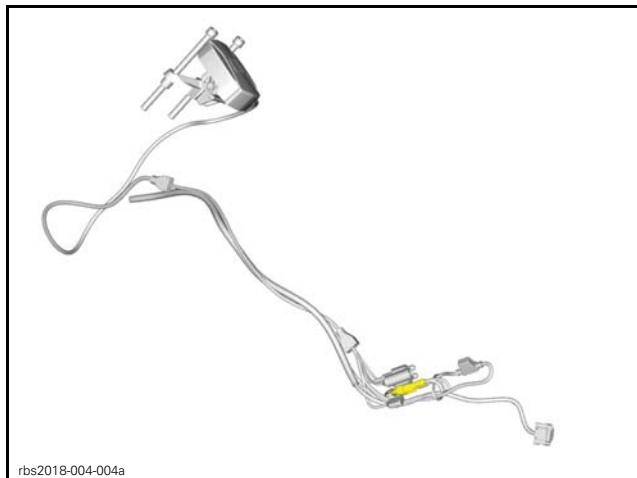
Vehicles equipped with GPS kit may experience inner battery charging issues. One of the probable cause is inverted wires at vehicle connector

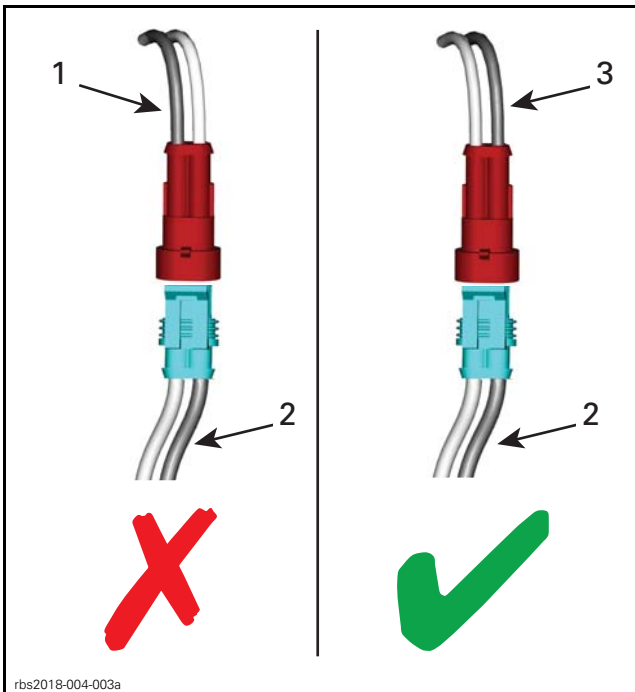
1. Black wire on female connector at the wrong location
2. Black wire on male connector
3. Black wire on female connector at the appropriate location

2. Make sure the black wire on the male connector is on the same side as the female connector.
