GROUP
Emissions
Service
Campaign

MODEL
2019-2021
Multiple Models
with IVT

NUMBER
SC199

**SUBJECT: IVT SOFTWARE LOGIC IMPROVEMENT
AND/OR IVT REPLACEMENT (SC199)**

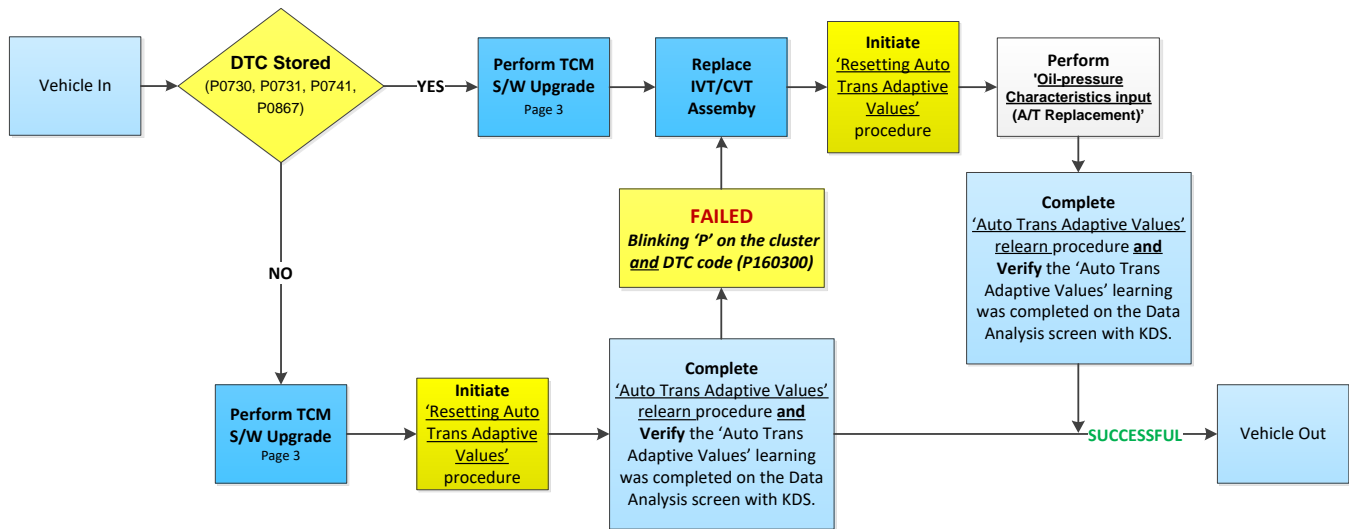
Flowchart:

Vehicle In DTC(s):

- P0730 – Incorrect Gear Ratio
- P0731 – Gear 1 Incorrect Ratio
- P0741 – Torque Converter Clutch Circuit Performance or Stuck Off
- P0867 – Transmission fluid pressure

After completing 'Resetting Auto Trans Adaptive Values' on the KDS:

- P160300 – P-Learning Fail (CVT System)

When replacing the IVT/CVT assembly, carefully follow the installation procedure outlined on KGIS to complete the Auto Trans Adaptive Values learning procedure. Performing the 'Oil-pressure Characteristics Input', refer to the IMPORTANT and NOTICE boxes on page 10. The adaptive values learning procedure may require that the engine be shut OFF/ON multiple times until the values are fully learned; start the vehicle, confirm the vehicle is idling in 'Park' without accelerator or brake input and verify the 'CVT Learning – P Range' Current Data reads 'ON'.

A **Vehicle Diagnosis Number (VDN)** must be created with at least one of the five (5) DTCs listed above, prior to IVT replacement. If a VDN is not created, **Parts Ordering and Warranty claim submission issues WILL occur.**
