GROUP ENG	MODEL 2021MY Stinger (CK) 2.0L T-GDI
	NUMBER 223	DATE December 2020
TECHNICAL SERVICE BULLETIN		
SUBJECT: SERVICE ACTION: ENGINE LOT INSPECTION AND SUB-ENGINE & TURBOCHARGER REPLACEMENT (SA458)

This bulletin provides information to inspect the engine Lot Number and if necessary, replace the sub-engine assembly and turbocharger on some 2021MY Stinger (CK) vehicles equipped with Theta 2.0L T-GDI engine, produced from October 14, 2020 through October 17, 2020, which may exhibit reduced engine performance with loud noise and/or MIL 'ON' with DTC P029900 due to poor oil flow to the turbo charger. Before conducting the procedure, verify that the vehicle is included in the list of affected VINs (94 VINs). Please perform this repair on all applicable vehicles in your dealer inventory prior to sale.

DTC Description:
P029900 - Turbo boost below target value

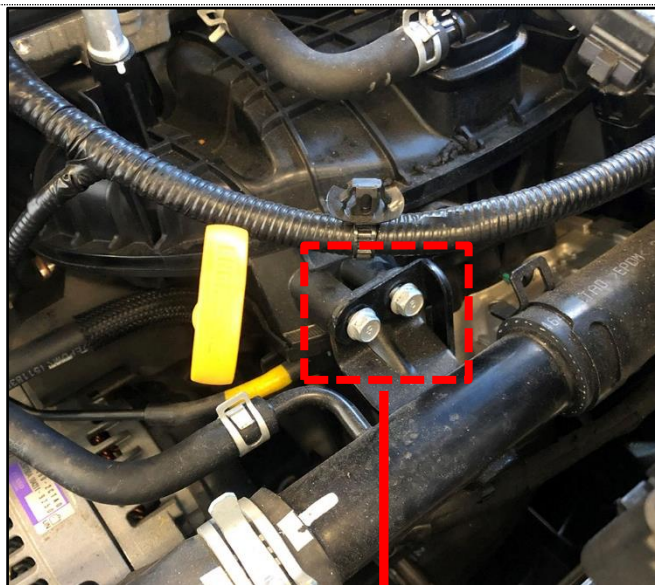
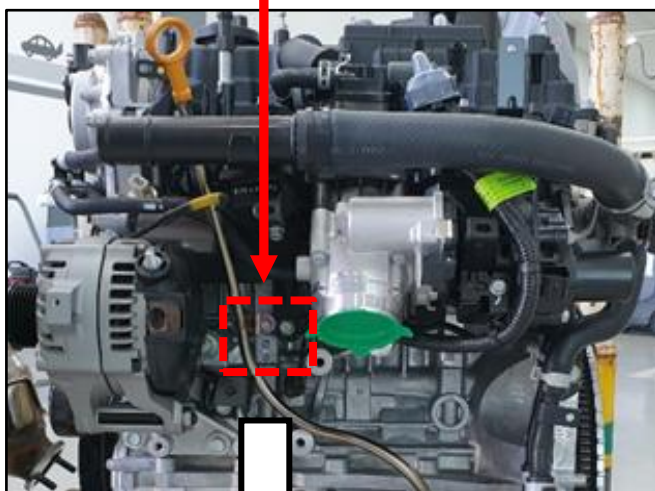
Note: It may be necessary to use a cell phone camera to clearly view/read the stamped lot number. The engine shown to the right has been removed and for reference use only.

- 3a. Check the Lot Number on the center of the cylinder block located behind the alternator.
- 3b. If the Lot Number falls within the engine production date range shown, then follow the 'Sub-Engine and Turbocharger Replacement Procedure' outlined on page 3.
- 3c. If the Lot Number **does not** fall within the engine production date range shown, no further action is required.
4. Reinstall the two (2) coolant line bracket retaining bolts from step 2a.

2007182216

Year Month Day Hour Min

Target Lot: **2008121100 - 2008121408**
