MODEL  
2018-2019MY  
Niro (DE HEV/PHEV)  
w/ 6-Speed DCT

NUMBER  
092

## TECHNICAL SERVICE BULLETIN

### 6-SPEED DOUBLE CLUTCH OR DCT REPLACEMENT

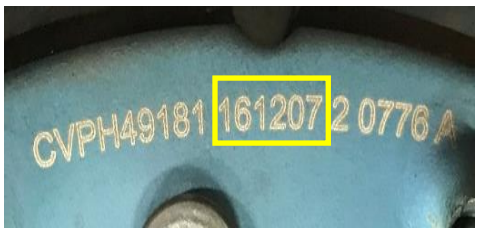
**Double-clutch Manufacturing Lot Identification Method [Applicable Lot No: 180810 through 190527]**

Check the lot number on Disc 1 (Engine Side)	How to check the manufacturing lot date: Example 10th -15th Digits: "161207"

8. Check the double-clutch manufacturing lot after removing the transmission.  
 a. If the double clutch manufacturing lot is subject to replacement, replace the double clutch by checking the number according to the method below.  
 b. If the double clutch manufacturing lot is not subject to replacement, replace the DCT Assembly with a new one.
