Applies To: **2009–11 Civic** – ALL VINs Beginning With 2HG

## Gap Between the A-Pillar Trim and the Headliner

(Supersedes 11-064, dated February 3, 2012, to revise the information marked by the black bars)

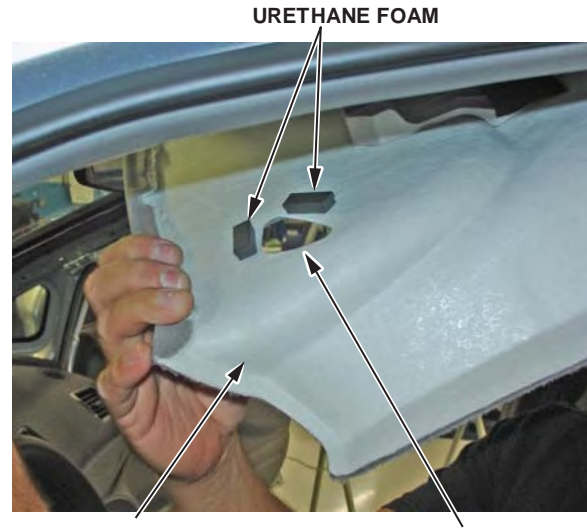
**LEFT SIDE**

There's a gap between the A-pillar trim and the headliner.

The tolerances vary between some A-pillar trim and headliners.

14. On the top of the headliner, attach two pieces of urethane foam near each sunvisor bracket opening as shown.
