December 24, 2020

MIL is Flashing with Loss of Power

AFFECTED VEHICLES

Year	Model	Trim Level	VIN Range
2019-21	RDX	ALL	ALL

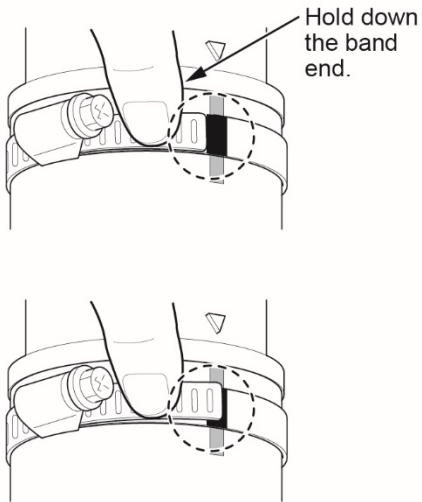
GOOD

The hose band end is **AT** or **WITHIN** the paint or hash mark on the hose band.

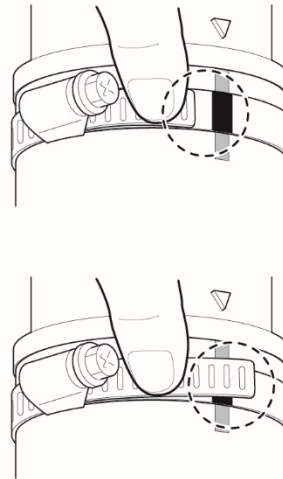
NO GOOD

The hose band end is **NOT AT** or **EXCEEDS** the paint or hash mark on the hose band.
