Technical Service Bulletin

RATTLING, CLUNKING OR POPPING NOISE FROM FRONT OF VEHICLE WHILE DRIVING

Bulletin No.: 09-005/20

2016-2020 CX-9

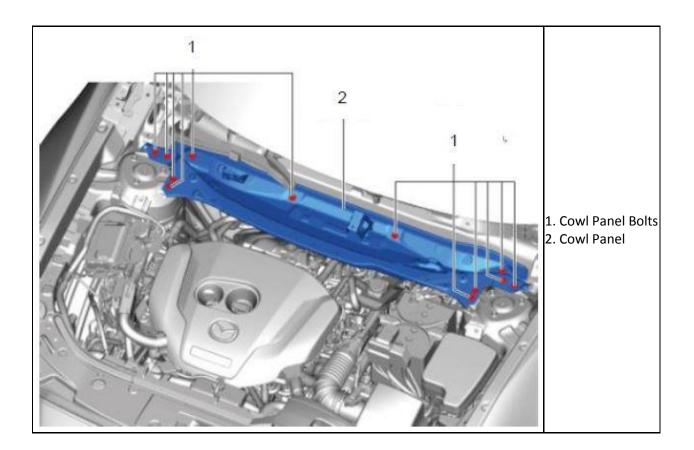
Some vehicles may exhibit a rattle, clunk or pop noise from the front of the vehicle while driving. The noise may be caused by loose cowl panel bolts.

- 1. Verify the customer concern.
- 2. Tighten all cowl panel bolts according to the instructions on MGSS online (COWL PANEL REMOVAL/INSTALLATION).
 - Tightening Torque: 29 ft.-lbf. {40 kgf-m, 40 N-m}
