Technical Service Bulletin

| Subject: DTC U2050:55 STORED AFTER REPLACING OR REPROGRAMMING TCU | Bulletin No.: 09-013/20 |

2019 Mazda3 vehicles (Japan built) with VINS lower than JM1BP*****147656 (produced before June 29, 2019)

2019 Mazda3 vehicles (Mexico built) with VINS lower than 3MZBP*****115095 (produced before June 29, 2019)

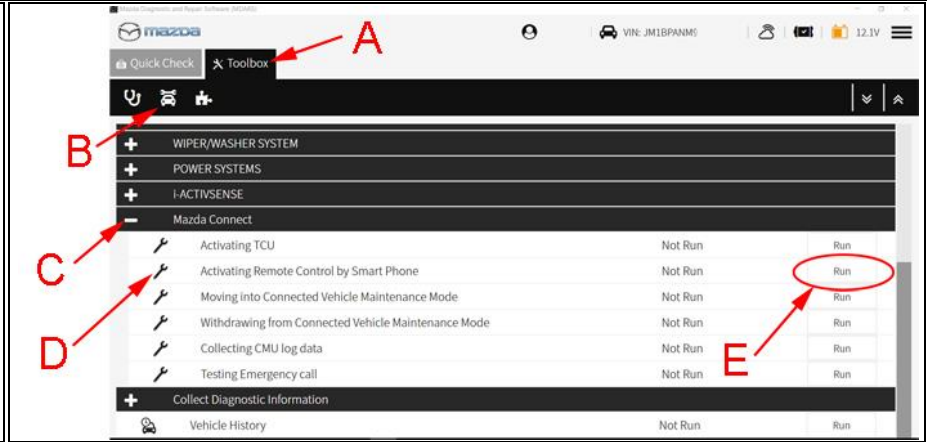
3b. Select the following:
 A. Toolbox
 B. Work support icon
 C. Mazda Connect
 D. Activating Remote Control by Smart Phone
 E. RUN.

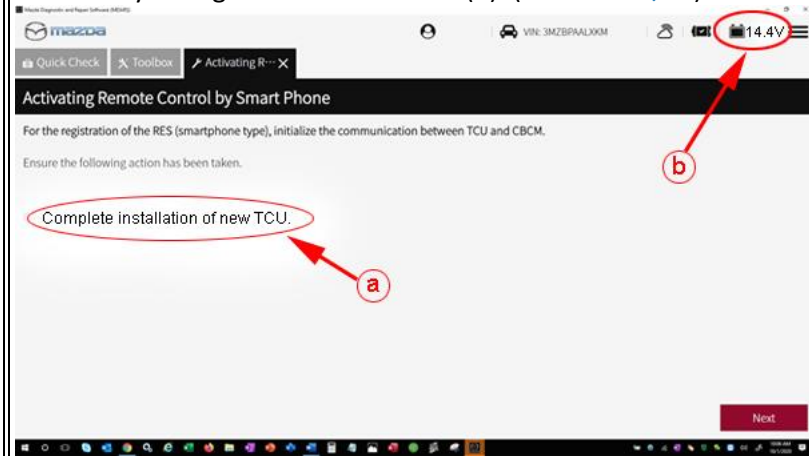
3c. Follow the on-screen instructions.
NOTE: Activating Remote Control by Smart Phone shows "Incomplete".

Possible causes:

1. The advanced key is not in the vehicle.
2. Connected Vehicle Maintenance Mode is enabled.
3. Key transmitter power saving function is enabled.
4. Pacemaker radio wave interference prevention function is enabled.

1. If TCU is not being replaced, ignore "Complete installation of new TCU" (a).
2. Battery voltage must be 14-14.5V (b). (see SA-063/20)

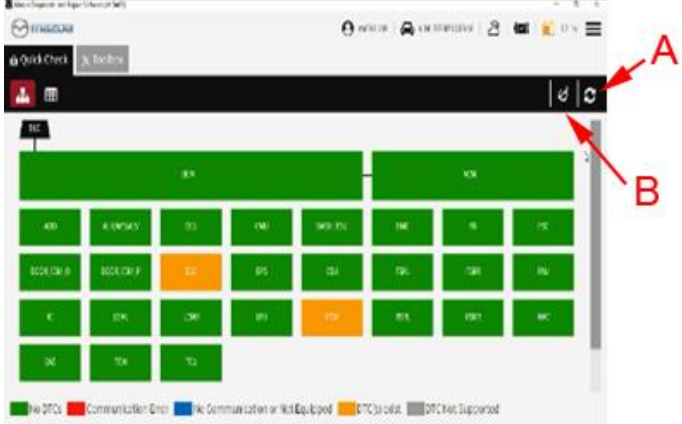
| <p>3d. Select Quick Check (A), then start the engine and select the DTC Clear icon (B).</p> <p>CAUTION: If the engine is not started, DTC P2610 is stored and cannot be erased.</p> | |
