Technical Service Bulletin

Subject: WRONG VEHICLE LOCATION IN GPS WITH DTCS B119F:01, B119F:13 AND/OR B119F:2B STORED	Bulletin No.: 09-021/20
	Last Issued: 12/10/2020

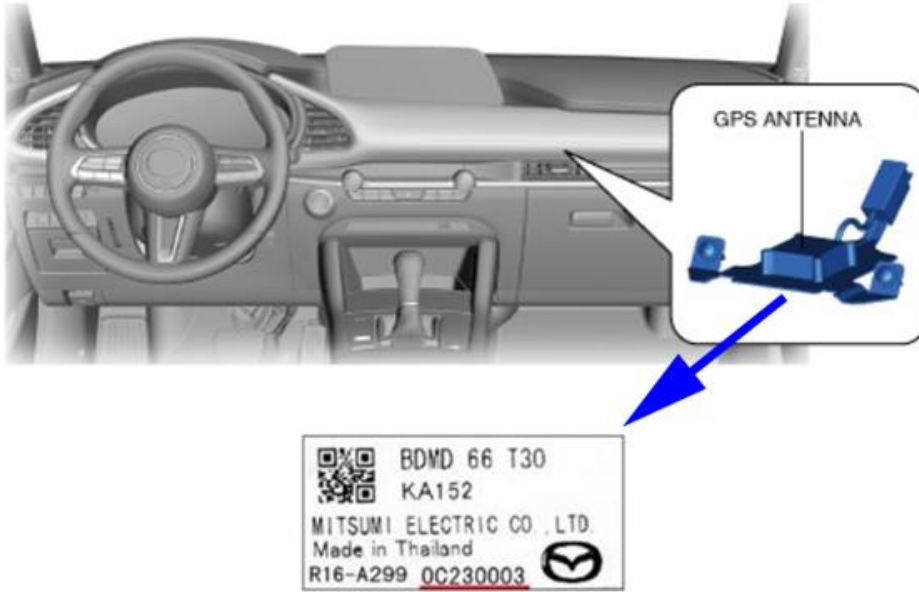
1. Verify customer concern.
2. Confirm if the telephone antenna No.1's lot number is before 0C230003. The lot number is in YMDDnnnn format.

0C230003: 0→2020 (year), C → March, 23→ 23th (day), 0003→serial number for the day
 9H161360: 9→2019 (year), H → August, 16→ 16th (day), 1360→serial number for the day

- If the lot number is 0C230003 or later, the part is already modified.
- If the lot number is before 0C230003, replace the GPS antenna with a modified one by referring to the instructions on MGSS.
 - Mazda3: (GLOBAL POSITIONING SYSTEM (GPS) ANTENNA REMOVAL/INSTALLATION)
 - CX-30: (GLOBAL POSITIONING SYSTEM (GPS) ANTENNA REMOVAL/INSTALLATION)
