Technical Service Bulletin

Subject: REAR ULTRASONIC SENSOR RUBBER SEAL(S) MISSING OR DAMAGED	Bulletin No.: 09-037/20
	Last Issued: 12/01/2020

2020 CX-30 vehicles with parking sensor system with VINs lower than 3MVDM*****137194 (produced before Mar. 25, 2020)

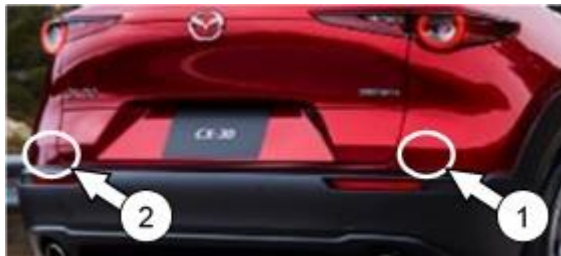
- (1) Rear ultrasonic sensor No. 1
- (2) Rear ultrasonic sensor No. 2

Some vehicles may have a rear ultrasonic sensor rubber seal that is either missing, deformed or comes off when wiping down the rear bumper.

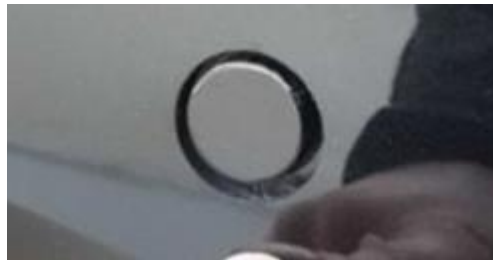
Rear ultrasonic sensor rubber seal is missing.

NOTE: Replace rubber seal(s) if they are lost or damaged.

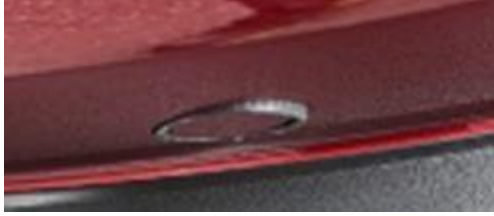
This concern is caused by the ultrasonic sensor sticking out too far from the rear bumper (as shown below). To eliminate this concern, the shape of No.1 and No. 2 ultrasonic sensor brackets have been modified.
