Subject: WATER ENTRY FROM THE REAR DOOR	Bulletin No.: 09-039/20
	Last Issued: 12/17/2020

2019-2021 Mazda3

2020-2021 CX-30

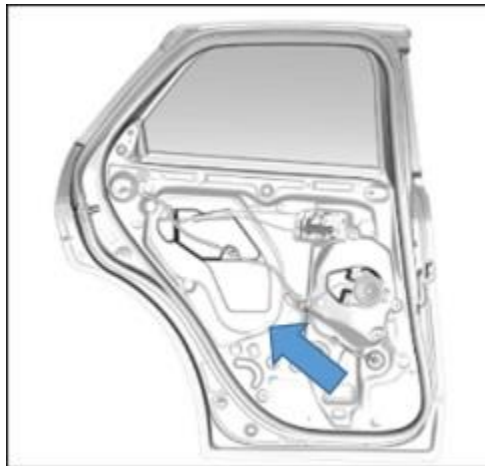
Some vehicles may exhibit water entering the passenger compartment from the rear door through the bottom of the service hole behind the rear door trim during rain or when washing the vehicle.

This is caused by one of the following:

- Since the material of the seal rubber is not resistant to surfactants, the rubber deteriorates when the vehicle is washed and allows water to penetrate into the seal rubber of the service hole cover.
- The lower tabs of the service hole cover may not have been completely engaged at the factory.

To correct this concern, the material of the seal rubber will be modified.

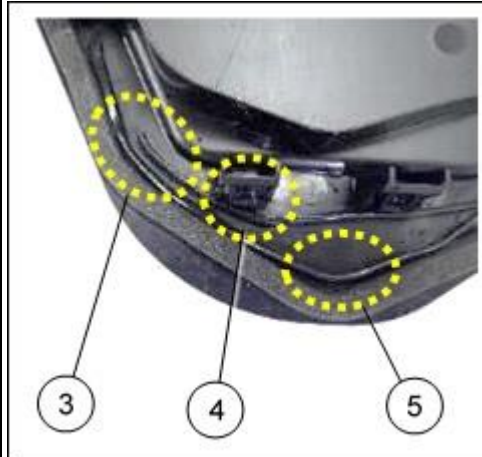
Examples of NOT CORRECT placement of tapes (image is of CX-30)

<p>(3) TAPE-2 does not adhere to TAPE-1. (4) TAPE-2 is away from the tab. (5) TAPE-1 does not adhere to the seal rubber.</p>
