Subject: BSM AND RCTA SYSTEM DO NOT WORK	Bulletin No.: 15-004/20
	Last Issued: 12/03/2020

- 2019-2020 Mazda3 (Japan built) with VINS lower than JM1BP*****161108 (produced before December 20, 2019)
- 2019-2020 Mazda3 (Mexico built) with VINS lower than 3MZBP*****138157 (produced before February 28, 2020)
- 2020 CX-30 with VINS lower than 3MVDM*****130147 (produced before February 28, 2020)

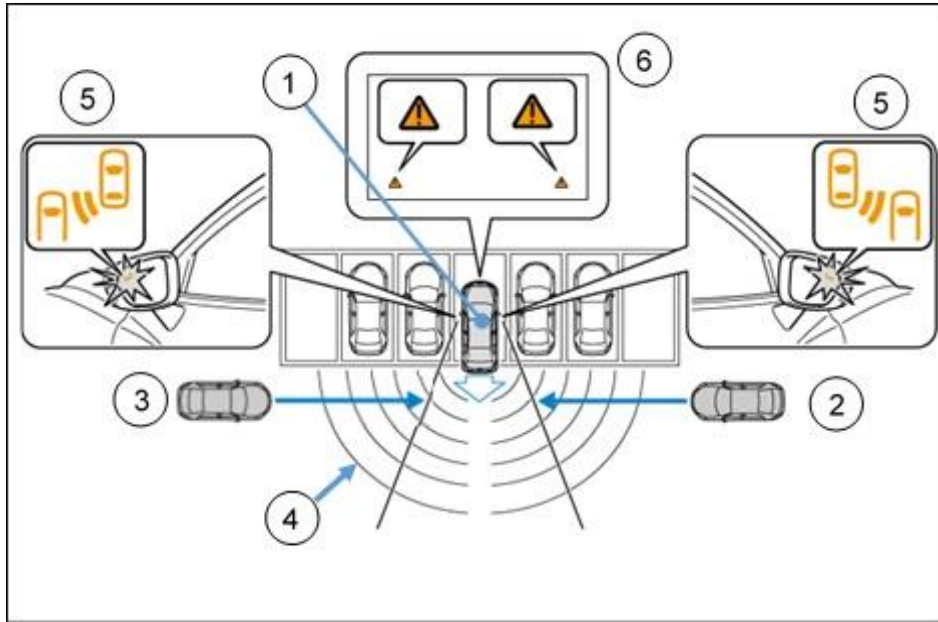
a. Park the concerned vehicle (1) and the approaching vehicle (2) as above.

NOTE: Confirm that there are no obstacles in the radar sensor microwave output range (4) of vehicle (1).

d. [Vehicle (1)] Confirm that BSM (5) indicator lights on the outer mirrors and RCTA (6) indication in the rear view monitor do not flash and BSM warning buzzer is not activated, even though vehicle (2) is approaching from the right rear.

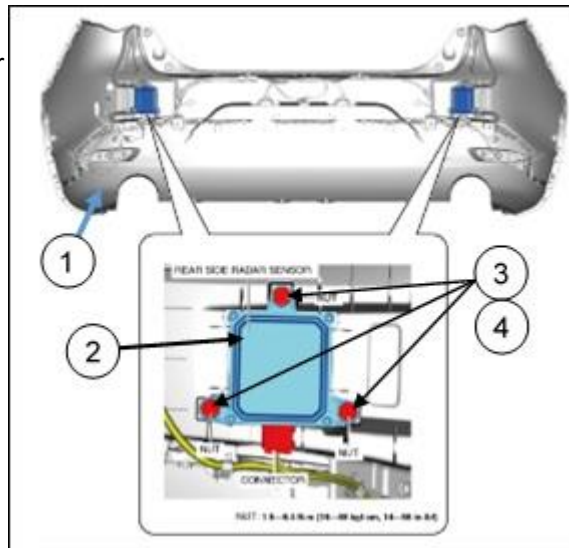
PARTS LOCATION

- (1) Rear Bumper
- (2) Rear Side Radar Sensor
- (3) Nut
- (4) Bolt, Radar

ATTENTION: When swapping the rear radar sensors, replace the sensor mounting bolts and/or nuts with new ones, depending on the model.
