Service Alert

CX-30 SERVICE CAUTIONS FOR NEW AND REVISED FEATURES

Service Alert No.: SA-013/20

2020-2021CX-30

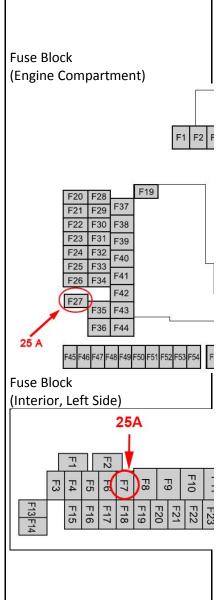
NOTE: Check for Connected Vehicle signal after installing room fuses. See the image below for how the connectivity signal bar looks (it's the vertical stack bar on the right bottom corner). This connectivity signal bar is not displayed on the "Home" screen. Go into the "Entertainment" or "Navigation" menu to check it. To confirm it is working properly, the bar should be white like the image below.

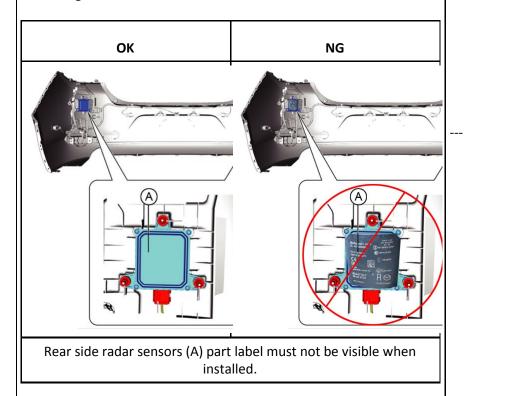
- 1. BSM system indicates vehicle on the opposite side.
- 2. i-ACTIVSENSE indicator ring will not turn green
- 3. Rear Cross Traffic Alert (RCTA) does not work
- 4. Rear side radar sensor aiming may fail
- 5. TPMS DTC(s) stored

This may be caused by BSM rear side radar sensor(s) installed facing the wrong direction.

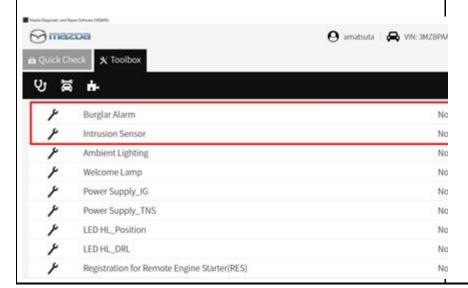
The CX-30 is not equipped with a Theft-Deterrent System. **CAUTION**: DO NOT use MDARS to enable:

The CX-30 does not have the necessary Theft-Deterrent System hardware to function if enabled using MDARS, and MDARS cannot disable the Theft-Deterrent System after it has been enabled. The following DTC's may be stored if the burglar alarm or intrusion sensor are enabled:

- 1. B109F:87 Intrusion Sensor Module
- 2. B2002:87 On Board Charger DC/DC Low Voltage Side Contact Hotline if the Theft-Deterrent System has been accidently enabled.
