**SERVICE BULLETIN**

**APPLICABILITY:** 2017-20MY Impreza  
 2018-20MY Crosstrek  
 2019-20MY Forester  
 2015-20MY WRX  
 2019-20MY Ascent

**NUMBER:** 12-306-20R

**SUBJECT:** Front Seat Squeaking Sound

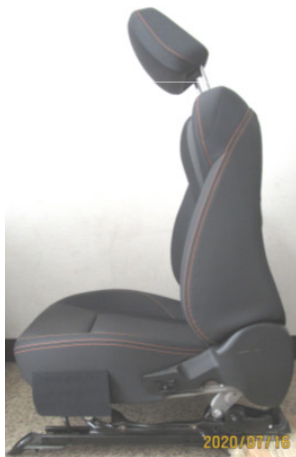
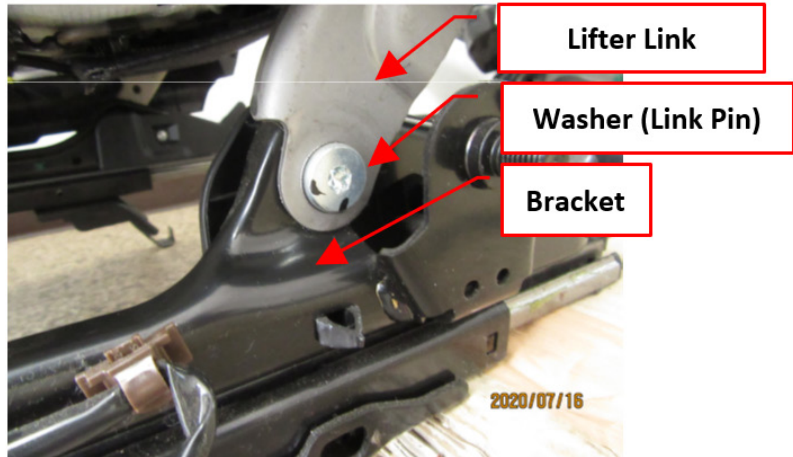
This bulletin provides a repair procedure to address a squeaking sound coming from the backrest hinge area of the front seats. The procedure applies to both manually and power operated seat assemblies. The sound is heard when the seat lifter mechanism is set to its lowest point. When in the lowest position, the lifter links as shown below may interfere with the brackets below them creating the squeaking sound. For production vehicles, new washers (link pins) have been incorporated to prevent the sound.

- 6) Apply Conoco-Phillips Red Grease #2 (or a suitable **Silicone-Free** equivalent) to the area shown below on both the outer AND inner contact points.

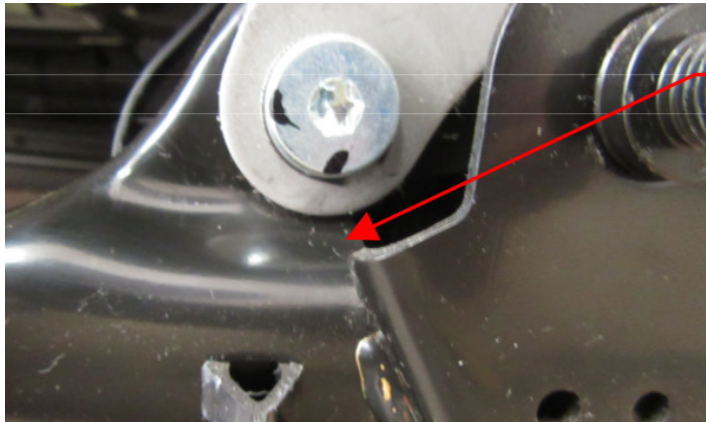
**When the Lifter is at the top position, there is space between the Lifter and the Bracket.**

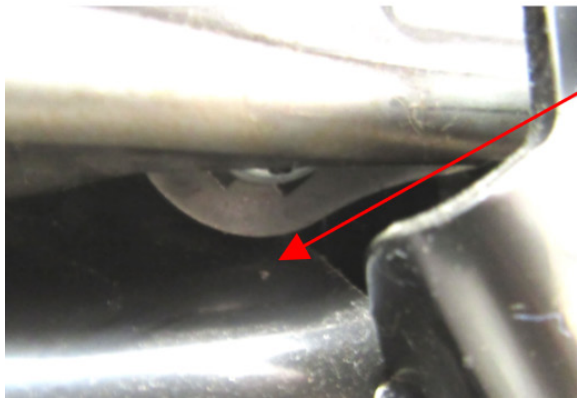
**When the Lifter is at the bottom (lowest) position, there is only a very small gap between the Lifter and the Bracket. In some cases, there may be a small “witness mark” created by the contact usable as a guide for where grease must be applied.**
