**SERVICE BULLETIN**

**APPLICABILITY:** 2017-18MY Impreza  
 2018MY Crosstrek  
 2018MY Legacy and Outback  
 2018MY BRZ\*

**NUMBER:** 15-211-17R  
**DATE:** 06/13/17  
**REVISED:** 12/18/20

**SUBJECT:** Reprogramming File Availability for Additional Optimization of Harman Gen 3 Audio and Navigation Head Units

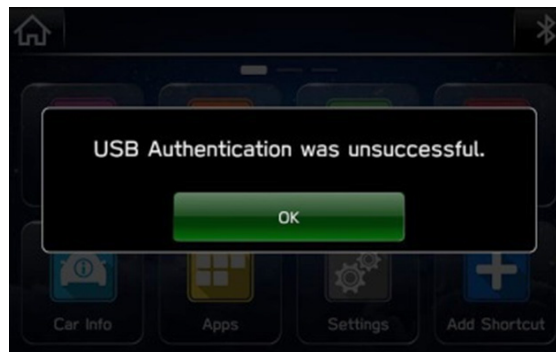
**NOTE:** If an attempt is made to install the wrong “grade” file into the wrong grade head unit (EXAMPLE: “Base” update file into a “Mid” or “High” head unit), the USB Authentication error screen below will be displayed:

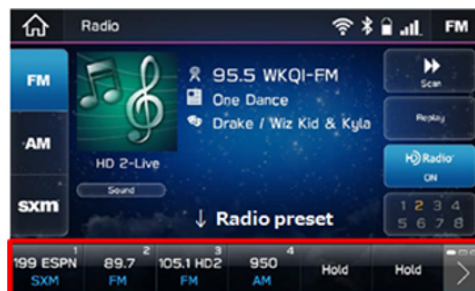
- Update to address some or all AM/FM station presets becoming lost and replaced by “Hold”

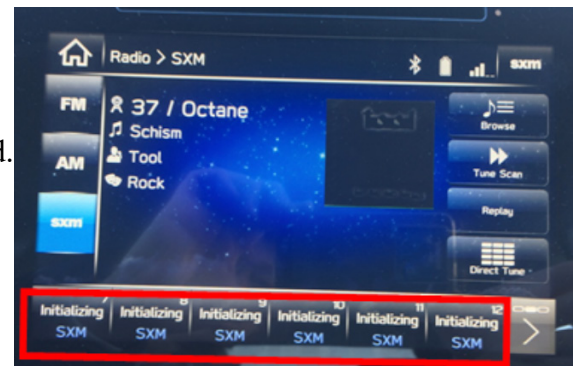
- On 2018MY Legacy / Outback models with Navigation (High) head units, the update corrects a condition where the head unit remains powered even after the ignition is OFF and the driver door is opened.
- Update for a condition where the SXM presets become lost and only “Initializing” appears as shown below.
- Update for condition where only the star field background is displayed (without icons) after the HOME button is pressed.

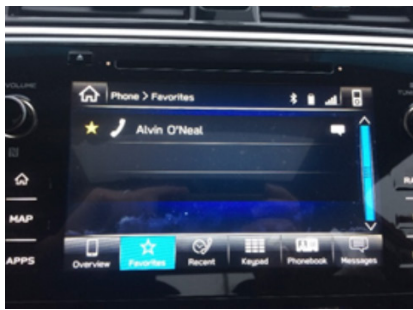
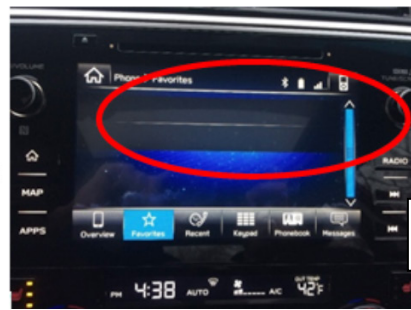
List is blank

- Update for a “Pop” or “Crackling“ sound concern when listening to AM radio.
- Update for a concern of the head unit continually resetting itself.
- Update for a concern of after selecting a contact to be a “Favorite” and the “Favorite” list display is blank.

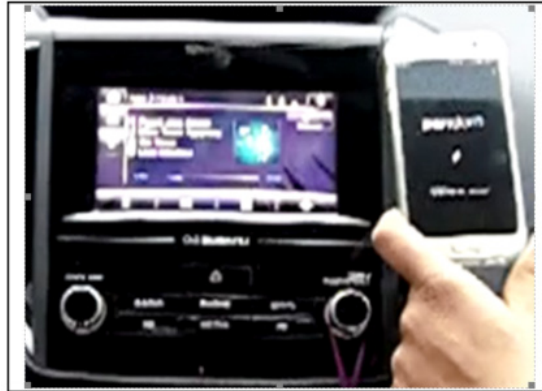
- 1- No streaming audio; when using the Pandora® app, there is no audio output.

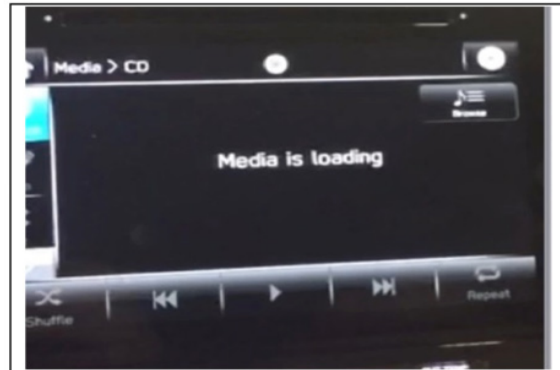
- 2- “Media is loading” is displayed on the screen but, the media never completes loading.

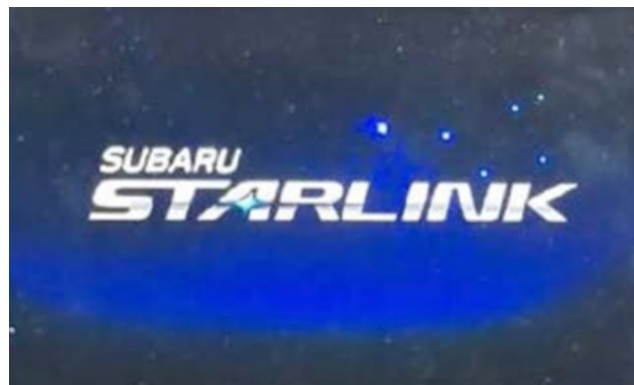
- 3- The screen freezes when the STARLINK screen is displayed.

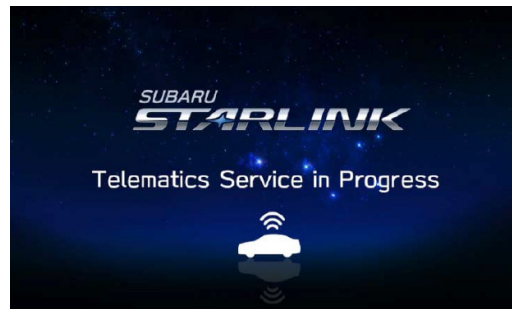
- 2- STARLINK “Telematics Service in Progress” screen freezes.

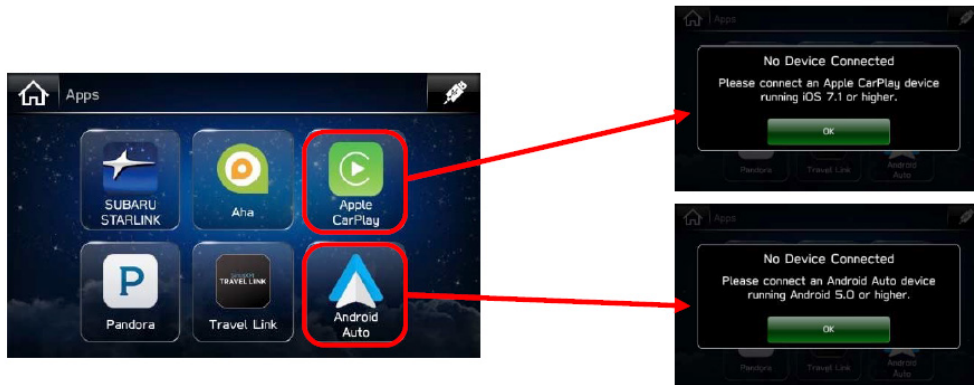
- 3- Apple Car Play / Android Auto function does not operate (“No Device Connected”).

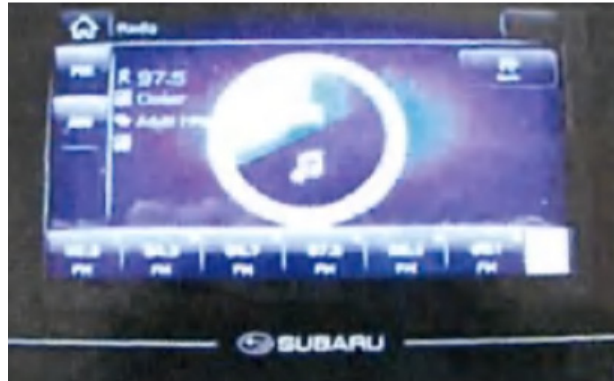
- 3) The time in the MFD automatically reverts to a “default” setting, even after setting the time using “Manual” mode.
- 4) Audio volume goes to maximum automatically after one click of the volume up button on the steering wheel. In some cases, this condition may also occur without input from the operator. Maximum volume is also displayed on the screen.
