SERVICE BULLETIN

NUMBER: 15-236-18R

SUBJECT: Reprogramming File Availability for Optimization of
 Harman Gen 3.1 and Gen 3.1α Audio and Navigation
 Head Units

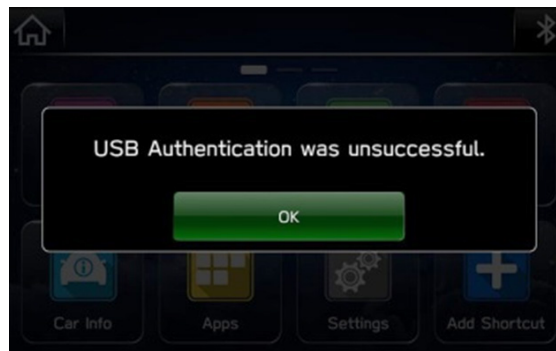
NOTE: If an attempt is made to install the wrong “grade” file into the wrong grade head unit (EXAMPLE: “Base” update file into a “Base Plus or Mid” or “High” head unit), the USB Authentication error screen below will be displayed:

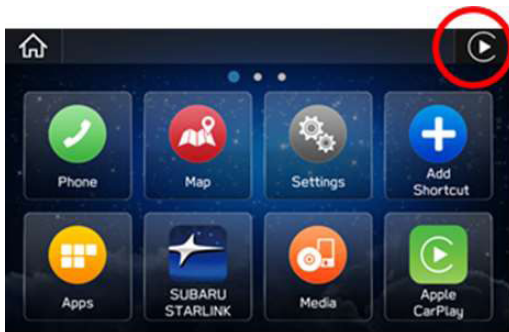
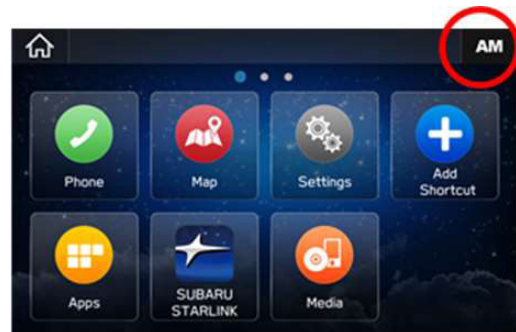
On Ver. 6.0 and before

NOTE 2: When the iPhone is disconnected while playing music through CarPlay, no music source is selected automatically anymore.

Music playing via iPhone in CarPlay.

After disconnecting, the music source is changed to Radio automatically.

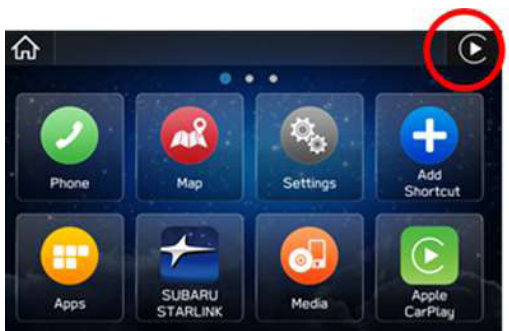
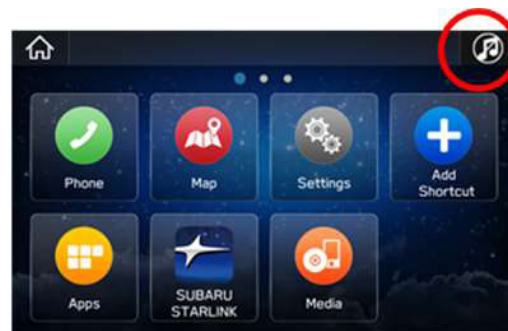
Music playing via iPhone in CarPlay.

After disconnecting, no music source is selected automatically.

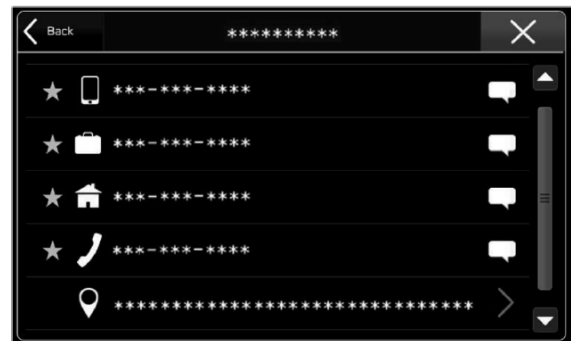
- 1) AM/FM radio station presets are lost.
- 2) Favorite Phone Contacts list is lost.

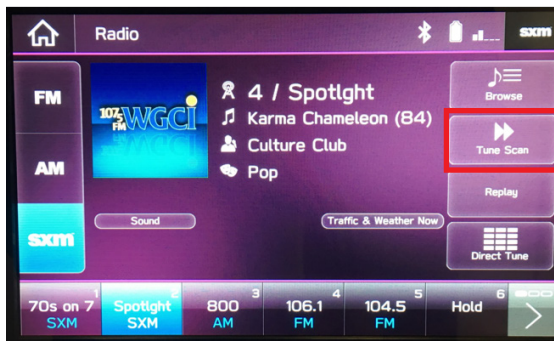
- 3) <Scan> previously displayed on SXM screen was changed to <Tune Scan> (a.k.a. SEEK).
