# **SERVICE BULLETIN**

2017-21MY Impreza 2018-21MY Crosstrek 2019-21MY Forester 2019-21MY Ascent **NUMBER: 16-132-20R**

**SUBJECT:** Diagnostic Information for Alleged Chain Slip Condition

on TR580 / TR690 Transmissions

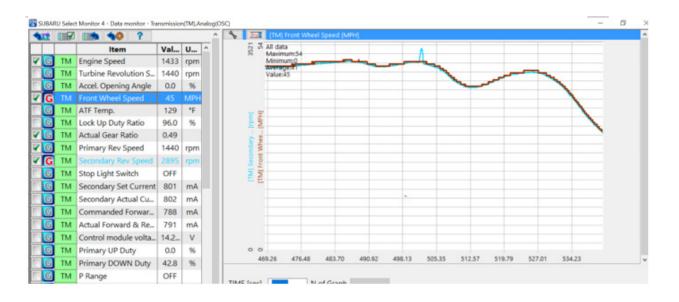
Example screenshot of TCM PIDS with Front Wheel Speed and Secondary Revolution Speed selected.

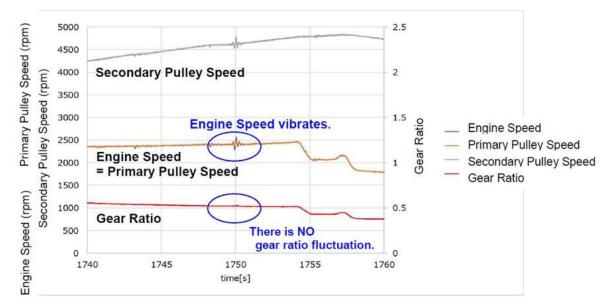
#### FIG. 6

The graph above is an example of recorded SSM data showing the torque fluctuation is NOT being caused by the transmission but by torque fluctuation of the engine.
