#### Rattle Noise From Under The Vehicle

18-21MY Range Rover, RR Sport  
19-21MY Discovery

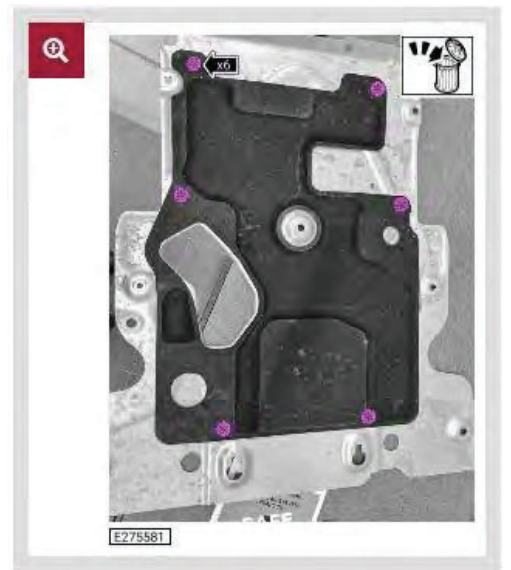
- The noise may be traced to the engine under-shield. The star washers that retain the sound absorber mat to the under-shield may have relaxed and not maintained proper clamping force.

- TSB JLRTB02065NAS1 will be published to address this concern by replacing the star washers with speed nuts to better clamp the damper pad.
