Technical Service Bulletin

19 Coolant leak in area of coolant thermostat housing/coolant pump - 2.0TFSI

19 20 10 2061604/1 December 14, 2020.

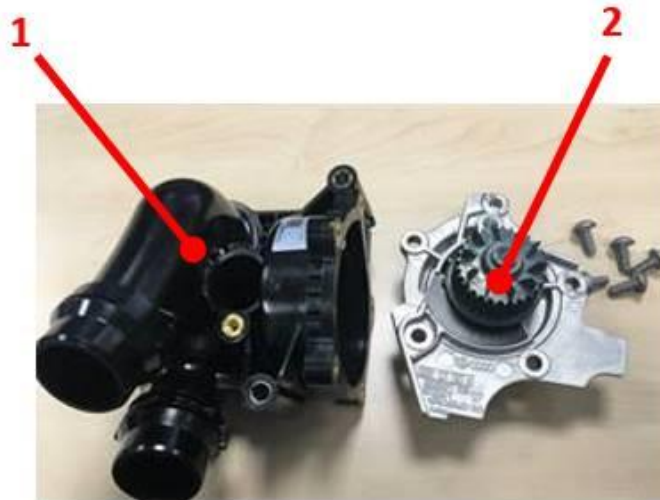
Coolant loss from the coolant thermostat housing (Figure 1, position 1) or the coolant pump (Figure 1, position 2).

Figure 1. Coolant thermostat/coolant pump. Parts are available separately, see parts table below.

Only replace the leaking component (coolant pump or coolant thermostat housing).

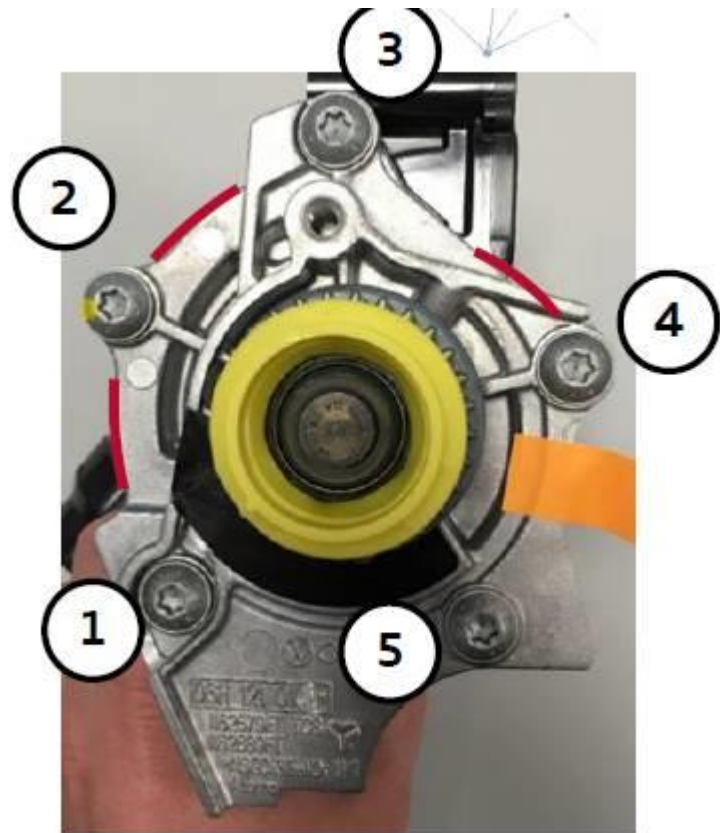
Figure 2. Securing bolts of the coolant pump (1 to 5).

- 2) Separate the water pump and coolant thermostat housing by removing the five connecting bolts (Figures 1 - 2).
- 3) Replacing the leaking component (coolant thermostat housing or coolant pump) with a replacement part, proceed as follows:

- Assemble the coolant thermostat housing and the coolant pump and attach the five connecting bolts.
- Align the two components against one another in such a way that both components are flush to one another in the areas marked in red (Figure 2). The thermostat housing must not be higher/lower than the coolant pump (run your finger over the three areas to check).
- Torque the connecting bolts of the two components to 10 Nm.

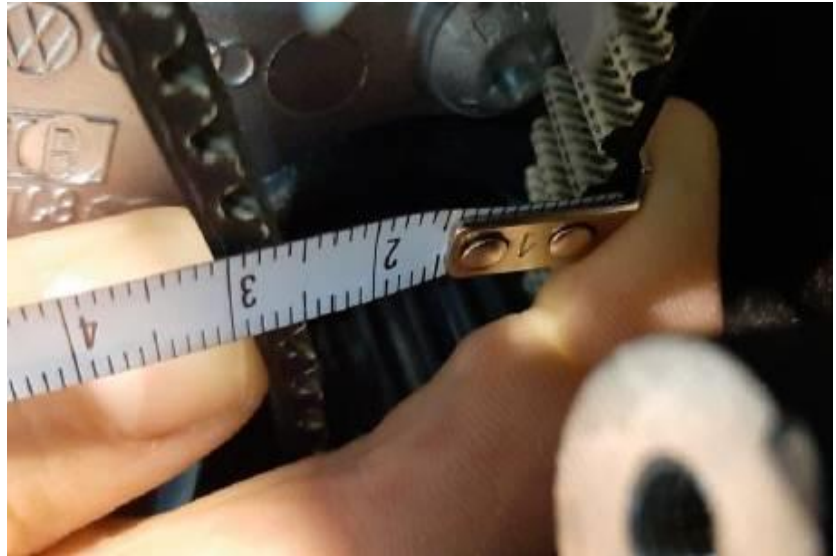
Figure 3. Checking the toothed belt tension.

- 5) Check the toothed belt tension (Figure 3) by pressing the toothed belt together centrally between the two toothed belt sprockets. The measured distance of the backs of the toothed belt should be between 28mm and 30mm. A measuring caliper can also be used for toothed belt compression and measurement.

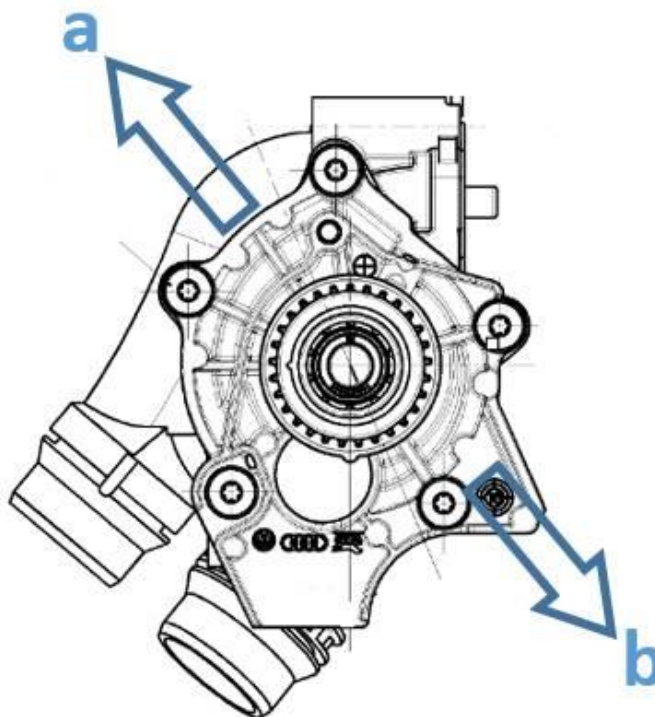
Figure 4. Adjusting the toothed belt tension.

- Note down the measured value (e.g. 26mm) from step 5).
- Remove the cooling module from the engine again, loosen the coolant pump bolts (Figure 2) and make adjustments as outlined below.
- If the measured distance of the backs of the toothed belt (pressed together) is less than 28mm (e.g. 25mm), then the belt tension is too low. A slight adjustment away from the balance shaft is necessary (**direction "a"**).
- If the distance of the backs of the toothed belt (pressed together) is greater than 28mm (e.g. 32 mm), then the belt tension is too great. A slight adjustment towards the balance shaft is necessary (**direction "b"**).

8. Tighten the five securing bolts of the coolant pump and repeat steps 4 and 5.
