Technical Service Bulletin

55 Paint spotting on top surfaces

55 20 51 2014055/8 December 18, 2020. Supersedes Technical Service Bulletin Group 55 number 11-13 dated April 14, 2011 for reasons listed below.

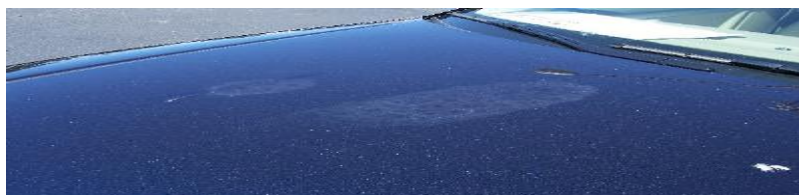
- After removal of the Full Body Cover, spotting, or discoloration in the paint of the top surfaces is found (Figures 1 - 2).
- Spotting appears as a stain or shaded area in the paint.

Figure 1. An example of discoloration in the paint.

Moisture is trapped under the Full Body Cover and against the painted surface, causing discoloration.

This condition may be temporary, and even in more permanent cases, this condition can be repaired. The severity of this condition will determine the course of action. Treat minor conditions as follows:

1. Hold heat gun approximately 3 inches away from affected paint surfaces and apply heat using slow oscillating motions until the discoloration is gone.
2. If the discoloration remains, wipe the heated area with isopropyl alcohol and repeat the procedure to increase surface drying.

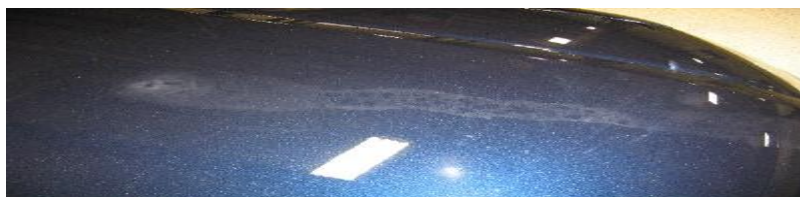
Figure 2. Another example of discoloration in the paint.

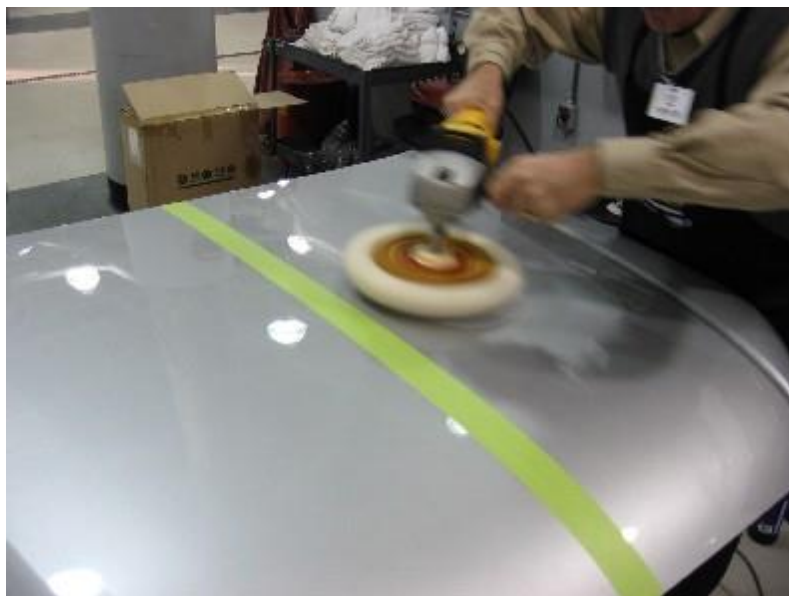
Figure 3. Buffing may be necessary to remove discolorations.

If this is not successful and buffing is required, follow these guidelines:

1. Ensure that the affected surface is completely clean, dry, and free of all dust and moisture.
2. Each buffing process will be done with a variable speed buffer set to 1,400 rpm. Using a double-sided 3M™ Superbuff Wool Pad attached to a 3M™ Superbuff Adapter, apply 3M™ Perfect-It™ Rubbing Compound to the stained area. Buff the area just enough to clear the stain.

3. Using a gray foam waffle pad attached to a 3M™ Perfect-It™ Backup Pad, apply 3M™ Perfect-It™ Machine Polish to remove the compound swirls.
4. Using a blue foam waffle pad attached to a 3M™ Perfect-It™ Backup Pad, finish the area with 3M™ Perfect-It Ultrafine Machine Polish™.
5. Buff entire panel for proper blending (Figure 3). Remove any remaining haze or residue with a detailing cloth. Apply wax to the repaired panel as necessary.
