Technical Service Bulletin

91 SOS warning displayed in instrument cluster, DTC B191604 is stored in the gateway control module

91 20 58 2051664/3 December 18, 2020. Supersedes Technical Service Bulletin Group 91 number 19-33 dated February 5, 2019 for reasons listed below.

Model(s)	Year	VIN Range	Vehicle-Specific Equipment
A4, A5, Q5, and Q7	2018	All	connected gateway

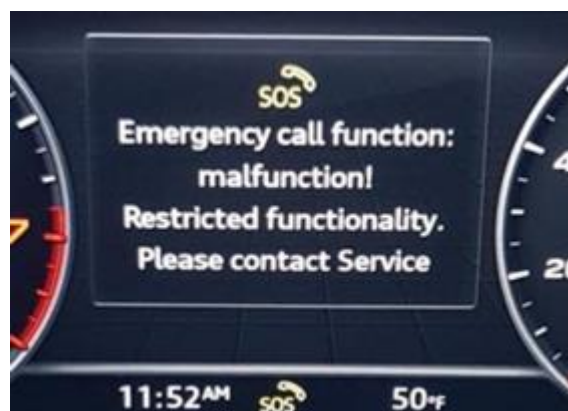
- The warning message "Emergency call function: malfunction! Restricted functionality. Please contact Service" appears in the instrument cluster (Figure 1).

Figure 1. The warning message is shown in the instrument cluster.

- **DTC B191604** (Backup battery Faulty).

Incorrect software parameter for the connected Gateway's back-up battery charge monitoring. The system must be reset by performing a manual discharge of the connected Gateway's backup-battery.

1. Perform a manual discharge of the connected gateway's back-up battery by removing constant power (KL30) and accessory power (KL15), while KL15 is switched on.

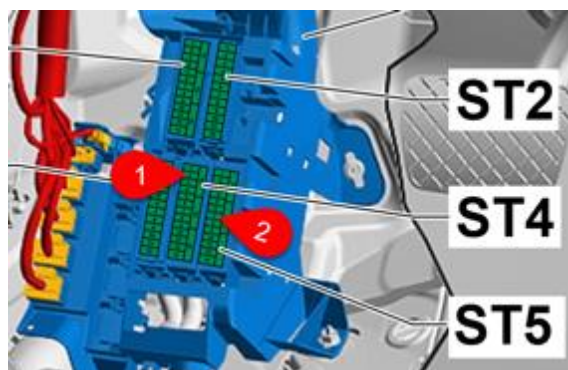
Figure 2. Q7 Driver's Side Footwell Fuse Box. 1: KL15 Fuse. 2: KL30 Fuse.

2. Gain access to fuse panel SB, located behind the driver's side footwell cover. Consult the repair manual for instructions on accessing fuse panel SB.
3. Locate the two fuses which supply constant power (KL30) and accessory power (KL15) to the connected gateway. Consult the wiring diagram or owner's manual for fuse location and size.
4. Ensure that accessory power (KL15) is ON.
5. Remove the two fuses identified in Step 3.
6. Wait 30 seconds with both fuses removed.
7. Reinstall the two fuses.
