JTBO0480NAS3

TECHNICAL BULLETIN

Intake Camshaft Variable Cam Timing Actuator - Component Failure

MODEL:	MODEL YEAR:	VIN:	ASSEMBLY PLANT:	APPLICABILITY:
XE (X760)	2017	942528-979442	Solihull	GTDi 2.0L Petrol

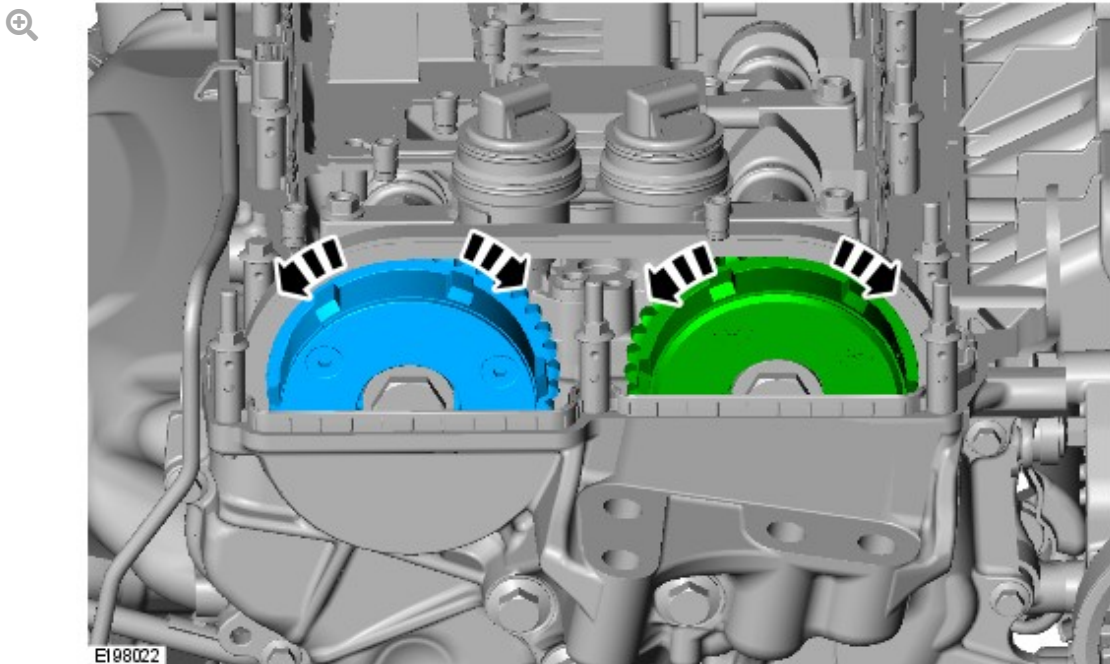
Please note the exhaust camshaft VCT actuator unit (shown in blue) has restricted movement when turned. The intake camshaft VCT unit (shown in green) has a less restricted movement when turned.

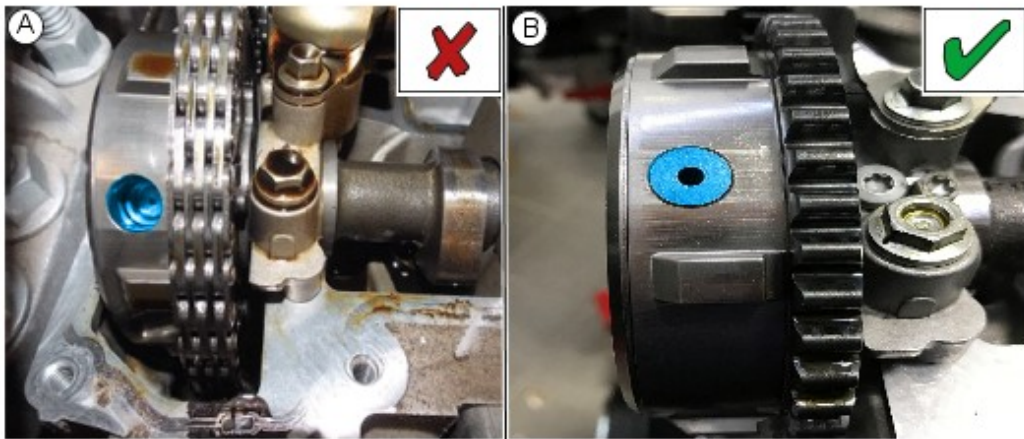
E186694

The 'stopper' in the intake Variable Camshaft Timing (VCT) actuator has become detached leading to the VCT unit not functioning.

Inspect the VCT actuator and if the 'stopper' has become detached proceed to step 4. If the VCT actuator is found to be noisy but the 'stopper' is in place proceed to step 3.

-
4. Refer to variable camshaft timing actuator (see Workshop Manual section 303-01: Engine - GTDi 2.0L Petrol - Variable Camshaft Timing Actuator).
