# Technical Service Bulletin

## 51 Water sloshing sound is heard while driving

51 20 18 2061754/1 December 18, 2020.

Model(s)	Year	VIN Range	Vehicle-Specific Equipment
A5 Sportback	2018 - 2019	All	Not Applicable

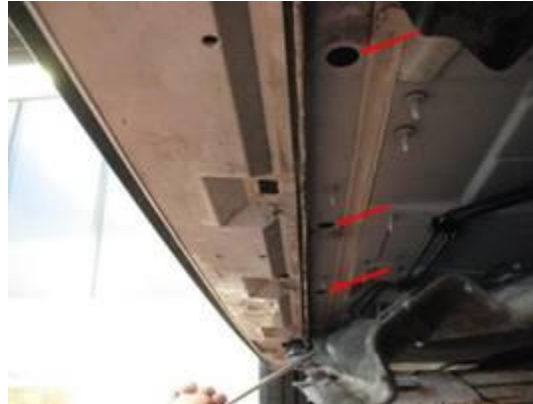
1. Detach the underbody trim until the plugs for the side member are accessible. If water has already accumulated in the sill areas water will flow from these plug openings (Figure 1).

*Figure 1. Access to the side member plugs.*

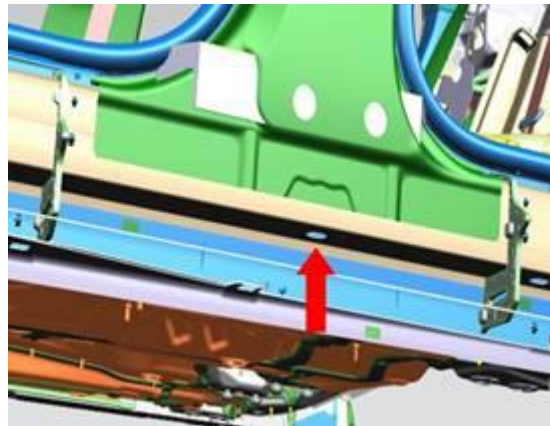
2. Figure 2 shows the opening where water generally enters this space.

*Figure 2. Water entrance point.*

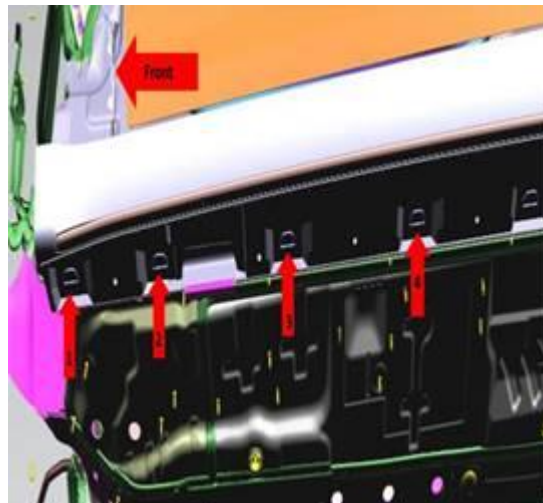
3. Fastener position number 4 shown in Figure 3 is the opening through which a modification to the sound absorber will be made.

**Figure 3.** Sill trim fastener openings.

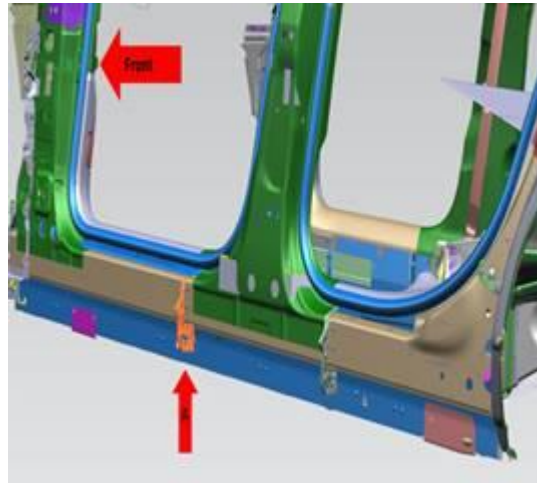
It is possible over time for water to accumulate in the side members and sills but the water is not able to drain as needed. The accumulated water is unable to reach the normal drainage because the sill cavity sound absorber blocks its flow. This accumulated water creates a 'sloshing' noise when the vehicle moves.

4. Figure 4 shows the location of the sound absorber marked 'A'.

**Figure 4.** Location of the sound absorber.

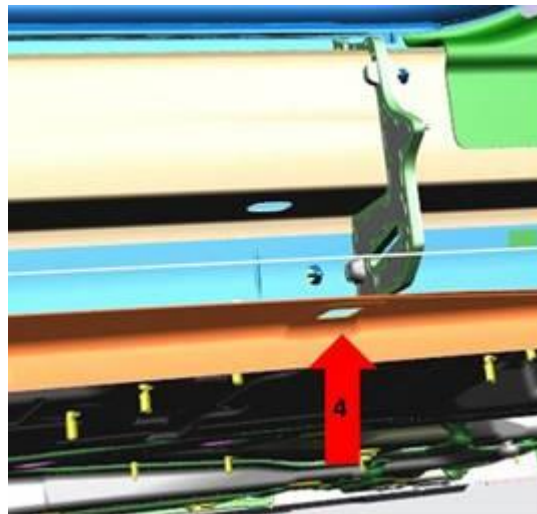
5. Figure 5 shows a closer view of the sound absorber to be modified in the cut-away image.

**Figure 5.** Hole through which the sound absorber will be accessed.

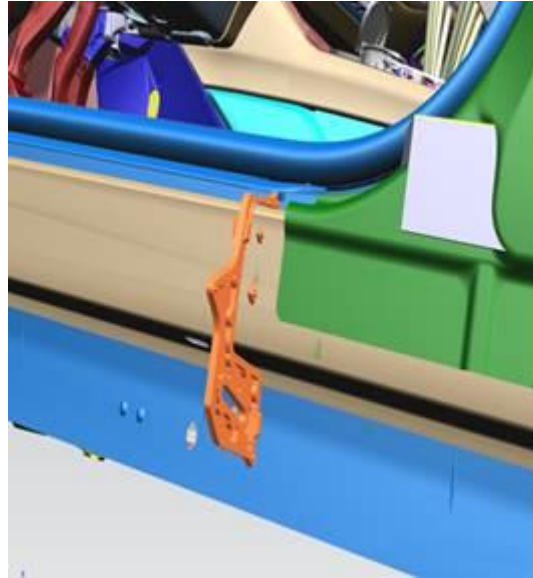
6. Figure 6 shows a cut-away view of the sound absorber from the rear.

**Figure 6.** Side member cavity sound absorber.

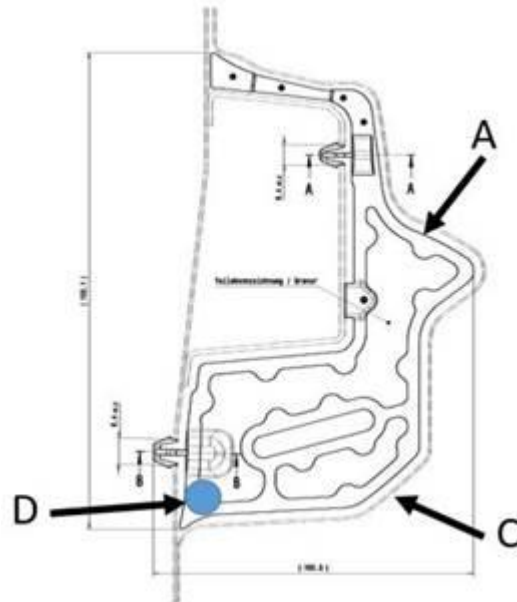
**Figure 7.** 8mm – 10mm hole to be made through the sound absorber.

7. Figure 7 shows a drawing of the sound absorber. The blue dot marked 'D' corresponds with a point through which a hole 8mm – 10mm in diameter will be made. This hole will allow for a normal flow of any accumulated water to reach the normal drainage and exit the sill cavity. The method for creation of this hole follows.

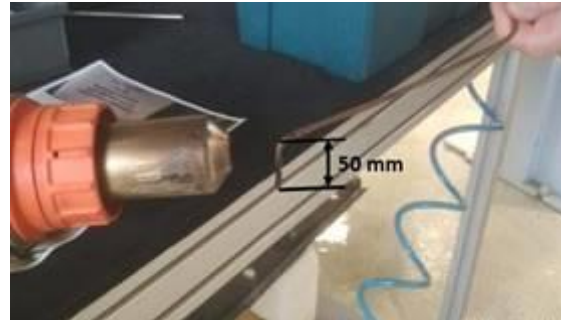
**Figure 8.** Heating the fabricated tool.

8. From a steel rod 8mm – 10mm in diameter fabricate a tool as shown in figure 8. Bend the end of it in an 'L' shape 50mm long.

Heat the bent end of the rod to approximately 500 °C (~932° F).

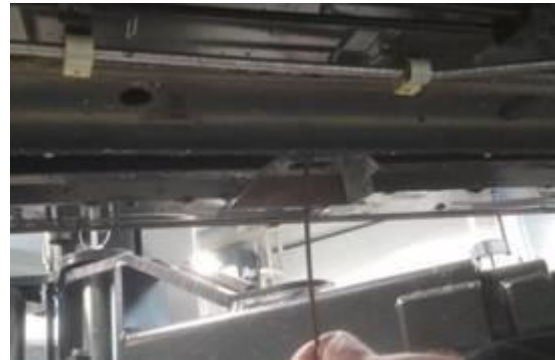
**Figure 9.** Making the hole in the sound absorber.

9. Guide the heated rod into opening number 4 from Figure 3 and melt a hole in the sound absorber in position 'D' from figure 7 (Figure 9).

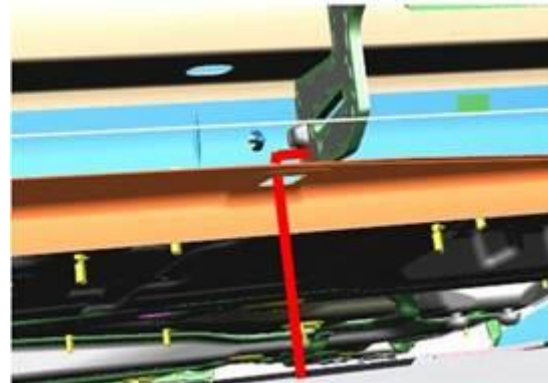
10. Figure 10 shows a drawing of the operation performed and the correct positioning.

**Figure 10.** Correct positioning of the heated rod.

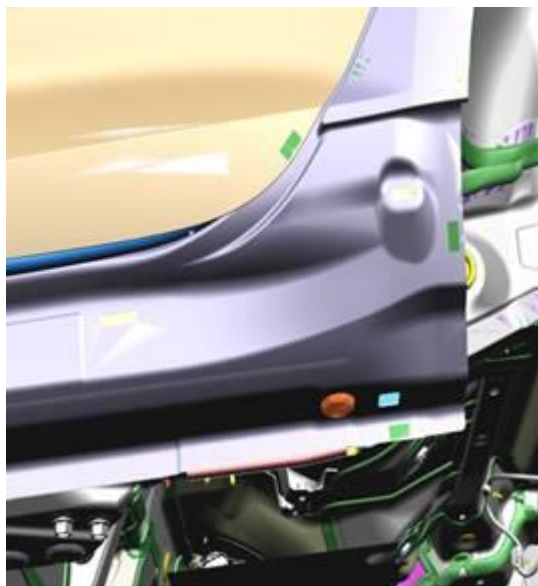
**Figure 11.** Drain plug on rear of the side member.

Ensure that the drain function of the draining plugs on the front and rear of the side members are fully functional and not damaged (Figure 11).

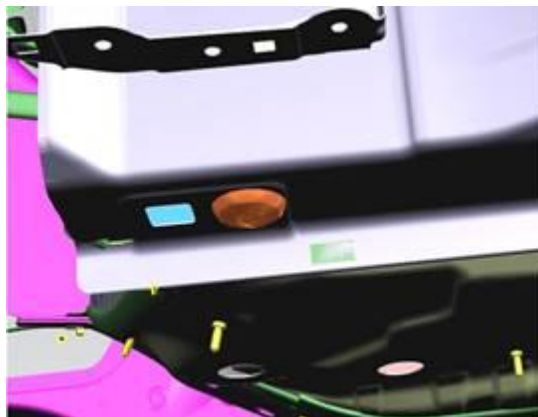
12. Figure 12 shows the drain plug on the front of the side member.

**Figure 12.** Drain plug on the front of the side member.
