Technical Service Bulletin

51 Cracking noises in right rear roof area during steering thrust

51 20 19 2060145/3 December 18, 2020. Supersedes Technical Service Bulletin Group 51 number 20-16 dated October 16, 2020 for reasons listed below.

Model(s)	Year	VIN Range	Vehicle-Specific Equipment
Q8, SQ8	2019 - 2021	All	Not Applicable
RS Q8	2020 - 2021	All	Not Applicable

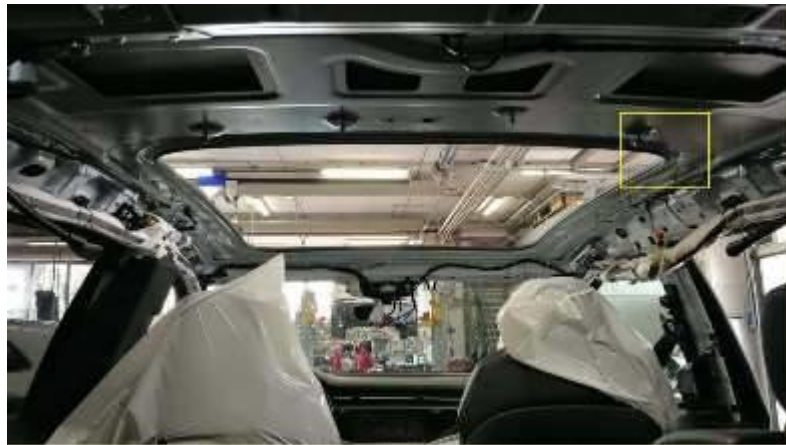
Figure 1. Right rear area of sunroof opening to be reworked.

1. Remove the headliner and sliding sunroof assembly. Figure 1 shows the area to be reworked in the rear of the sunroof opening, beginning with the right rear.

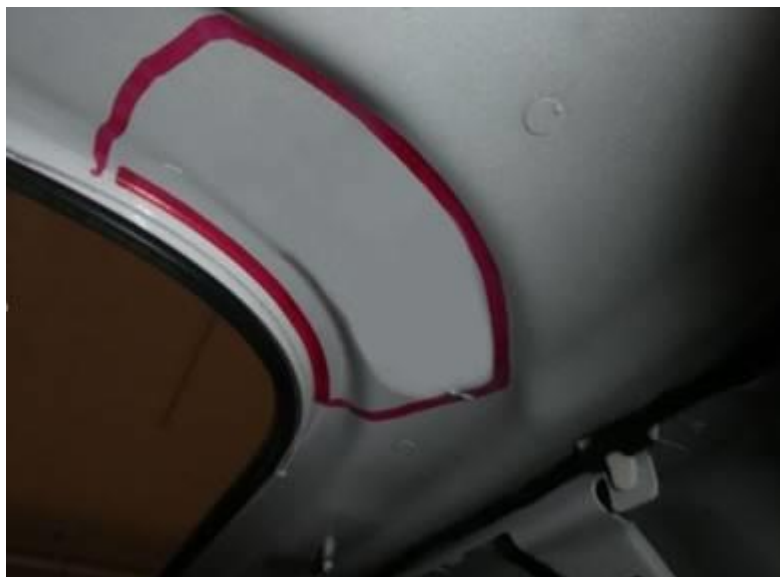
Figure 2. Area to be reworked.

2. Figure 2 shows a close-up view of the area to be reworked.

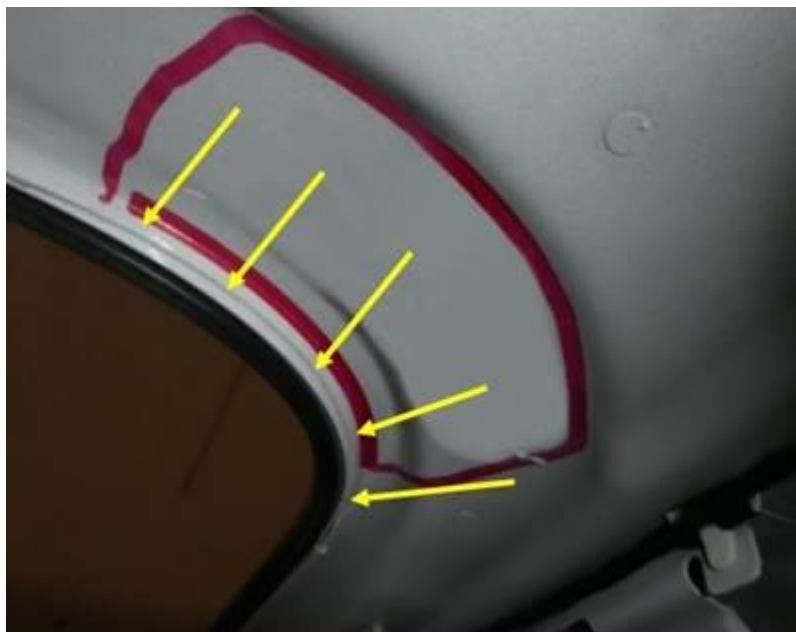
Figure 3. The yellow arrows show the joining seam of the outer roof sheet metal to be separated from the inner roof support.

3. The outer roof sheet metal is to be separated from the inner roof support (Figure 3).

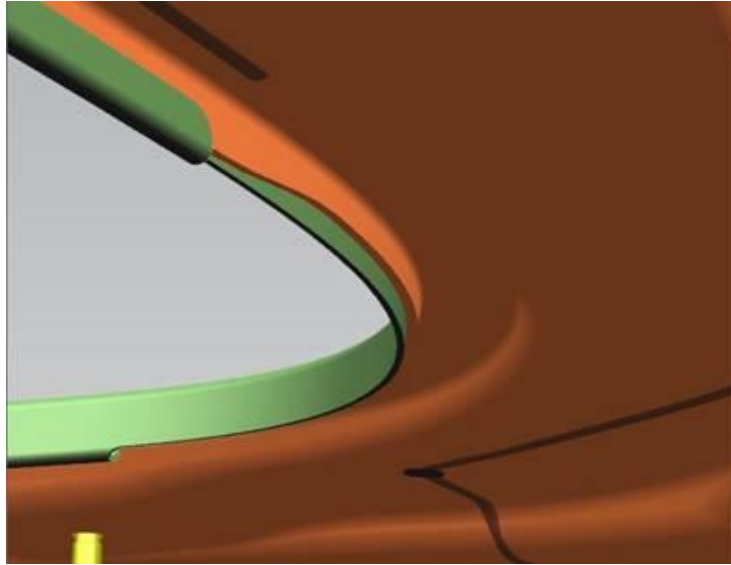
Figure 4. The section colored green is to be separated from the section colored orange in this drawing.

4. The drawing in Figure 4 shows the adjoining sheet metal that will be separated.

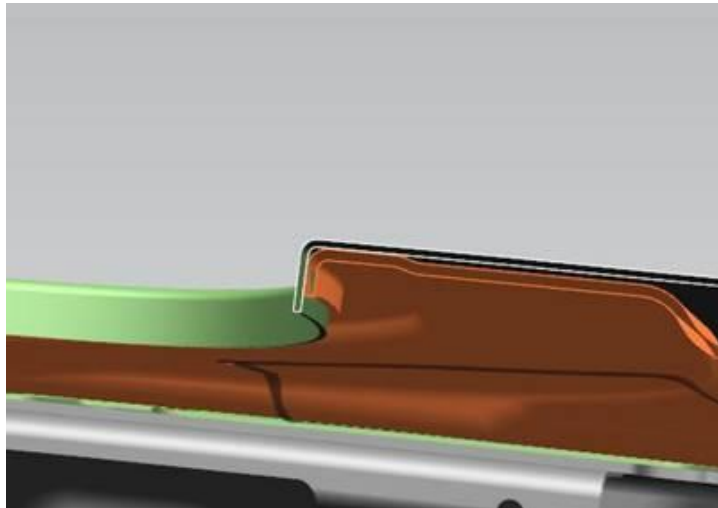
Figure 5. Cut-away view of the adjoining sheet metal that will be separated.

5. Figure 5 shows a cut-away view of the adjoining sheet metal that will be separated.

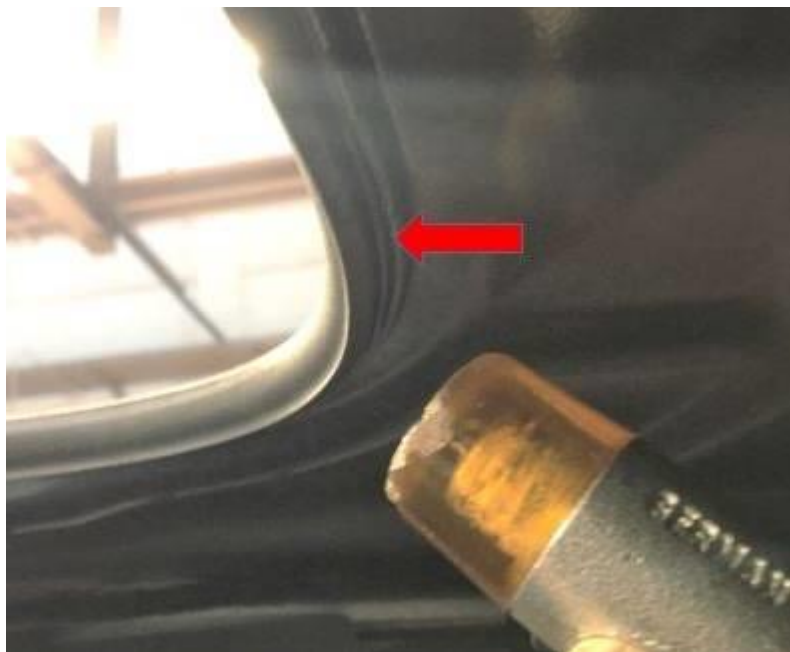
Figure 6. Area of sheet metal to strike with a plastic mallet.

7. Figure 6 shows the area of the roof sheet metal to strike with a plastic mallet. A light strike should suffice.

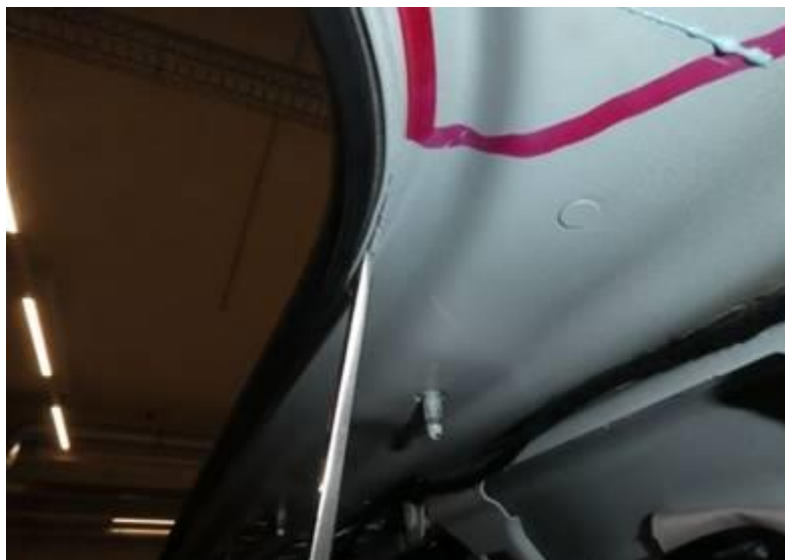
Figure 7. Adhesive joint separated.

8. If separation of the sheet metal proves to be more difficult than a light strike of a plastic mallet will produce use a small screw driver or small chisel to break away the adhesive (Figure 7).

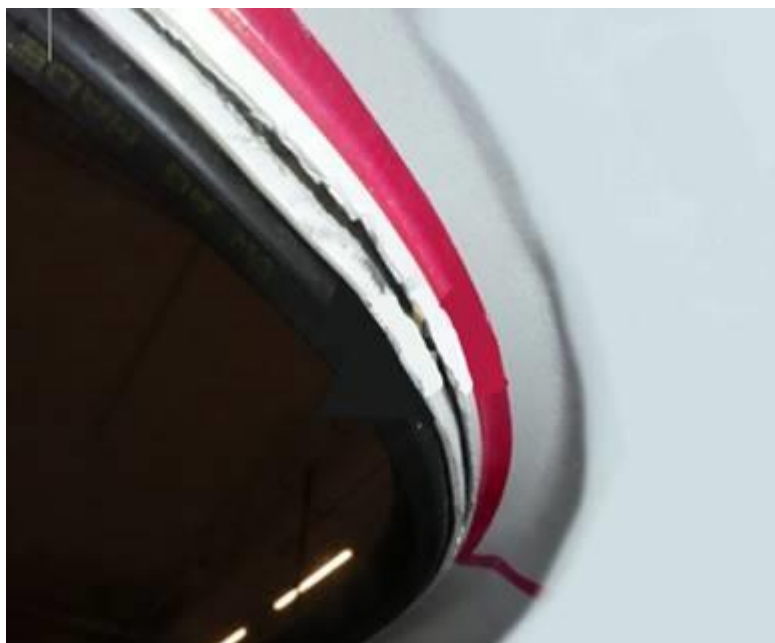
Figure 8. Create a gap of approximately 1mm.

9. Separate the adjoining sheet metal approximately 1mm (Figure 8).

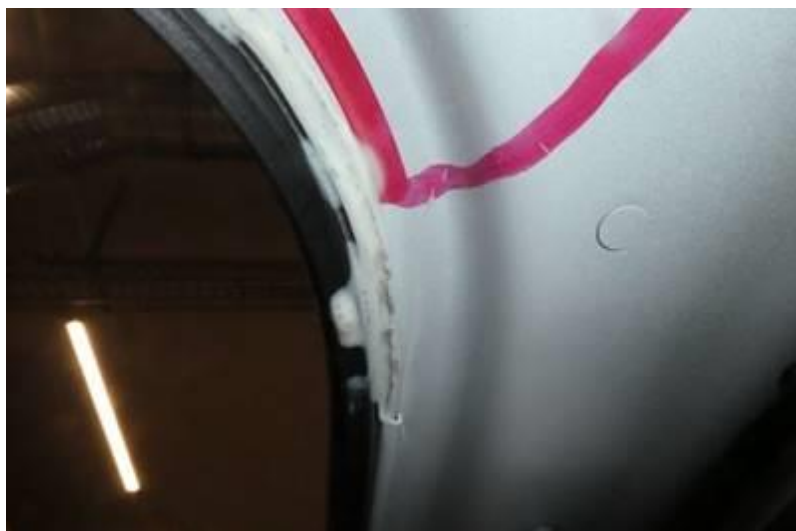
Figure 9. Gap created filled with Cavity Wax.

10. Through this gap fill the cavity with 08852 Cavity Wax Plus (Figure 9).
