Technical Service Bulletin

40 Creaking/squeaking noises from front end on uneven roads

40 20 21 2043424/11 December 7, 2020. Supersedes Technical Service Bulletin Group 40 number 20-18 dated November 24, 2020 for reasons listed below.

Model(s)	Year	VIN Range	Vehicle-Specific Equipment
A3	2015 - 2021	All	Not Applicable

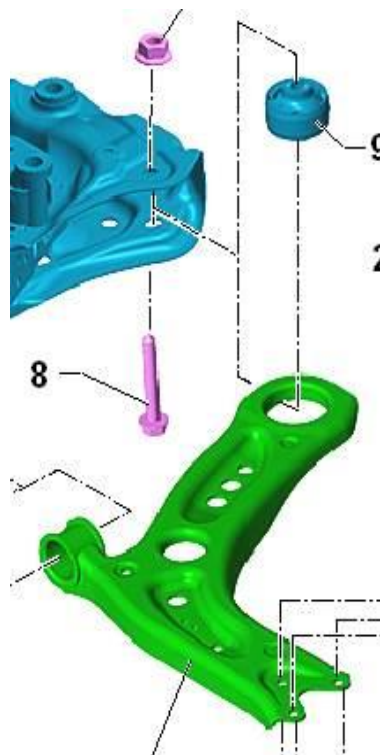
Overview of the lower control arm and bushing (Figure 1).

Figure 1. Lower control arm and bushing.

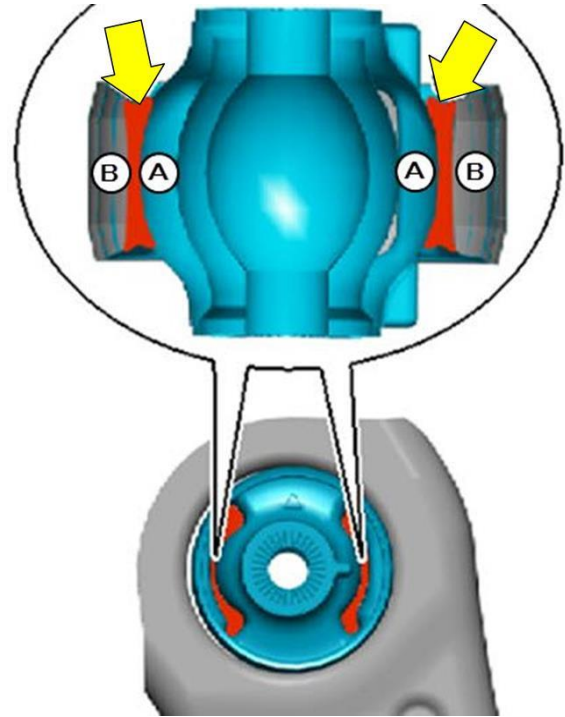
The rear bonded rubber bushings of the front lower control arms have a kidney-shaped slits (Figure 2). When the vehicle is driven on uneven roads, areas A and B (Figure 2) may come in contact, creating the creaking/squeaking noise.

Figure 2. Kidney-shaped slits (yellow arrows) of the rear bonded rubber bushings.

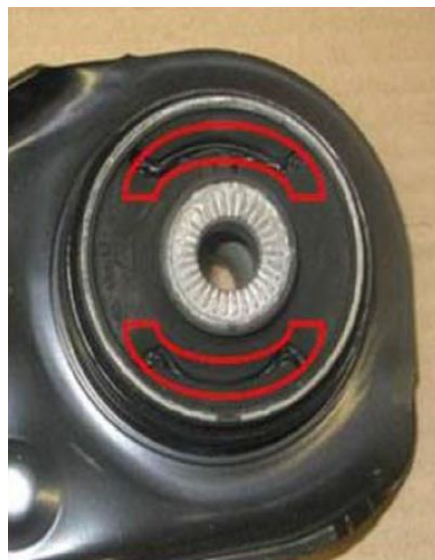
Figure 3. Lithium grease is applied on the red highlighted area only.

2. Evenly grease the kidney-shaped slits of the bonded rubber bushing (Figure 3, the area shown red) from above with 0.1g of lithium grease (part number G 052 150 A2). Use a paint brush to apply the grease.

The lithium grease must only be applied to the areas shown in red (Figure 3).
