Technical Service Bulletin

91 Washer system sprays automatically and uses an excessive amount of fluid

91 20 53 2053997/3 December 18, 2020. Supersedes Technical Service Bulletin Group 92 number 19-22 dated October 9, 2019 for reasons listed below.

Model(s)	Year	VIN Range	Vehicle-Specific Equipment
A6, A7, A8, Q8, and Audi e-tron quattro	2019 - 2020	All	With laserscanner
Audi e-tron Sportback	2020	All	With laserscanner

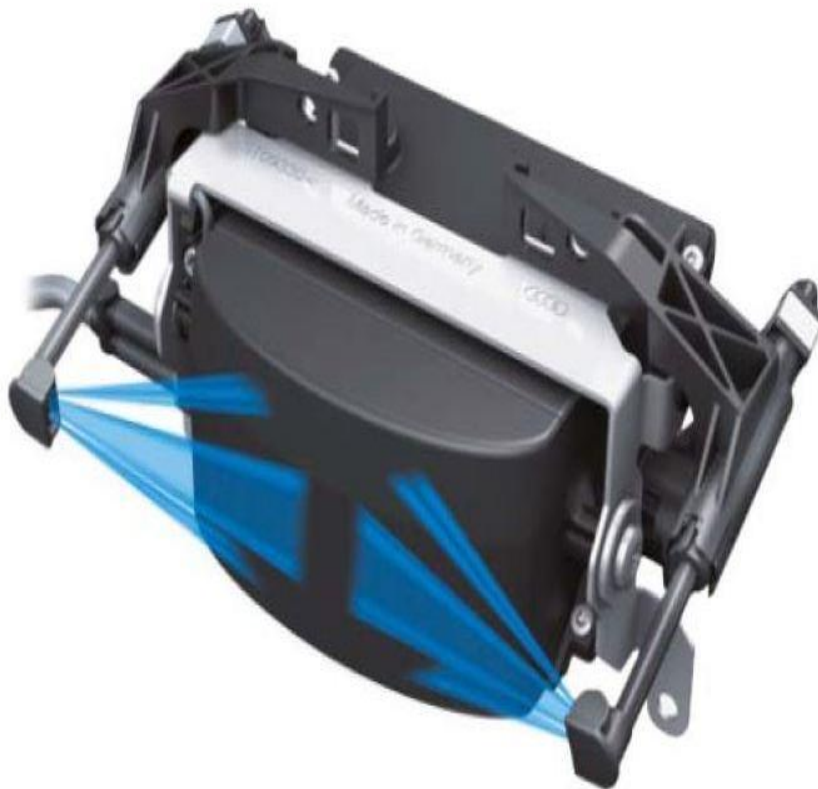
Figure 1. Laserscanner cleaning system.

If the laserscanner recognizes dirt on its screen, a message is sent to the onboard supply control module, J519 (address word 0009). Then it instructs the windscreen washer pump, J1100 to clean the laserscanner. The laserscanner is only cleaned while driving (Figure 1).

As a result, the customer can get the impression that the headlight washer system activates itself. Depending on weather and road conditions (like snow, slush or dirt roads) the laserscanner might clean itself frequently.

There is a software update for the laserscanner, J1122 (address word 00CD) that addresses the problem.

With the new software, the cleaning feature of the laserscanner “times out” after three unsuccessful attempts at cleaning the laserscanner for at least 45 minutes.

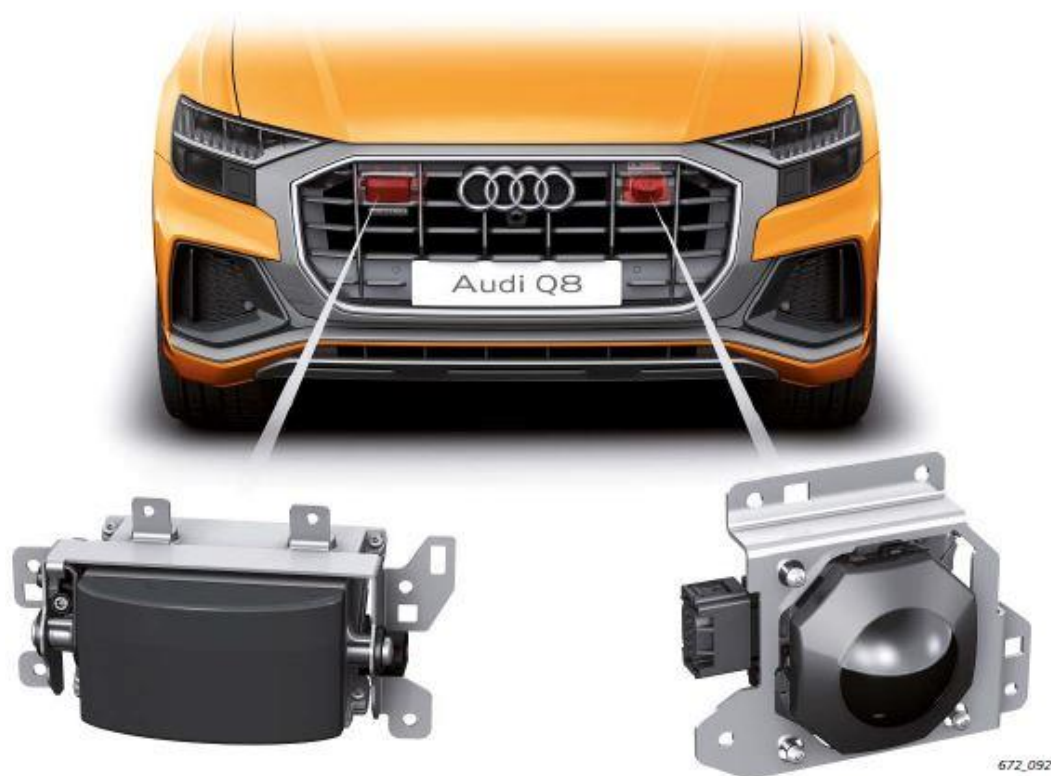
Figure 2. Laserscanner locations (A6, A7, and Q8).

On the A6, A7, and Q8 vehicles the laser scanner is located in the right upper single frame area (Figure 2).
