60 Noises in the sunroof mechanism

60 20 47 2050904/4 December 7, 2020. Supersedes Technical Service Bulletin Group 60 number 20-41 dated May 6, 2020 for reasons listed below.

Model(s)	Year	VIN Range	Vehicle-Specific Equipment
A3, S3	2018	000001 - 050429	Not Applicable
A3 Sportback	2018	000001 - 092806	Not Applicable
RS3	2018	90000 - 905321	Not Applicable

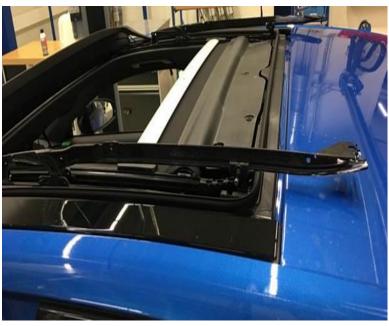
During a certain production period, the sunroof mechanism sliding rails were contaminated with a lubricant incompatible with the approved lubricant. When the correct approved lubricant was applied to these contaminated areas the correct lubricant did not adhere to these areas. These areas were then susceptible to noises when in contact with adjacent components of the sunroof mechanism.

Figure 1. Sliding rails exposed showing the area of contamination.

The areas of contamination will need to be thoroughly cleaned and dried, then the correct lubricant can be applied. Open the Panoramic sunroof fully. While Figure 1 shows the glass panel removed for clarity, the glass panel does not need to be removed to perform this operation.

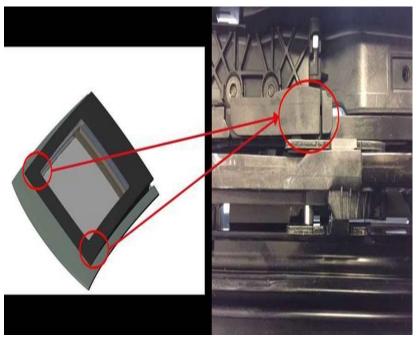
Figure 3. The locking mechanism in the guide rail.

4. Completely open the glass lid. The picture (Figure 3) shows the locking mechanism in the guide rail.

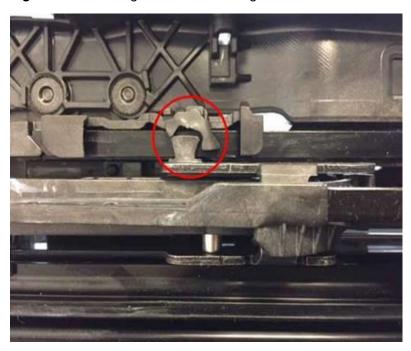
The two components in the circle touch each other and rattle when the glass panel is tilted. To fix the rattle, the grease must get in between the components.

Figure 4. The part that causes noise.

Please do not remove anything here.

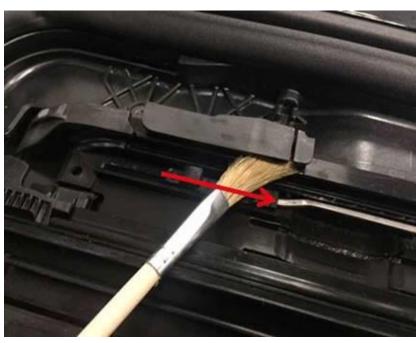
Figure 5. How to apply the grease.

Apply a pea-size amount of grease on a small brush. Use the special paste G 052 141
 A2. Move the brush (as shown in Figure 5) from front to back through the locking mechanism.

Tip: The direction of the movement is very important, otherwise, major damage could be caused to the roof system and the body.

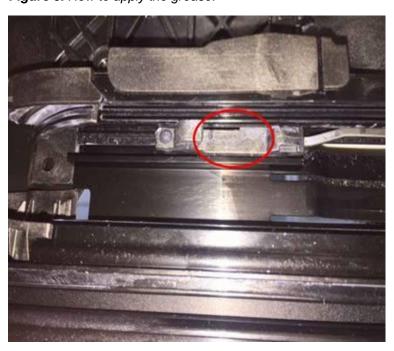
Figure 6. Unlocked mechanism.

7. The next picture (Figure 6) shows the mechanism unlocked.

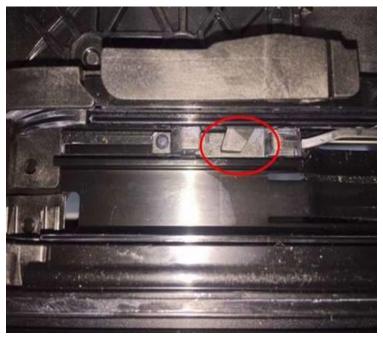
Figure 7. Locked mechanism.

At the end of the repair, the mechanism must be locked.
