60 Sunroof glass panel or sunroof rollershade do not operate

60 20 48 2054505/2 December 9, 2020. Supersedes Technical Service Bulletin Group 60 number 19-27 dated April 2, 2019 for reasons listed below.

Model(s)	Year	VIN Range	Vehicle-Specific Equipment
Q7, SQ7	2017 -2019	All	Not Applicable
A5, A5 Sportback	2018 - 2019	All	Not Applicable
A7	2019	All	Not Applicable

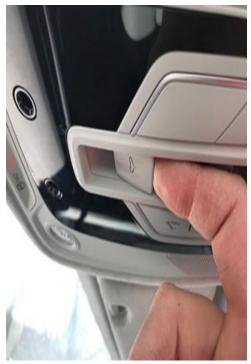
Figure 1. Set the sunroof panel basic settings by pulling the sunroof switch fully downward.

1. To set the basic settings on the sunroof glass panel drive the sunroof panel must be fully closed first. One-touch function is likely to be inactive so the panel may need to be closed holding the switch.

With the sunroof panel fully closed pull down the sunroof switch fully (past both detents) and hold it in this position (Figure 1). After 6 – 7 seconds the sunroof panel will begin to move rearward to its stop then move fully forward until fully closed. Do not release the switch from this position until the entire sequence is complete. Releasing this switch during the sequence will cause the basic settings to fail. It must then be repeated starting with a fully closed sunroof glass panel.
