68 Glove box door is binding when opened or closed

68 20 26 2060899/2 December 2, 2020. Supersedes Technical Service Bulletin Group 68 number 20-25 dated October 7, 2020 for reasons listed below.

| Model(s) | Year | VIN Range | Vehicle-Specific Equipment |
|---|---|---|---|
| Q5, SQ5 | 2019 - 2020 | All | Not Applicable |

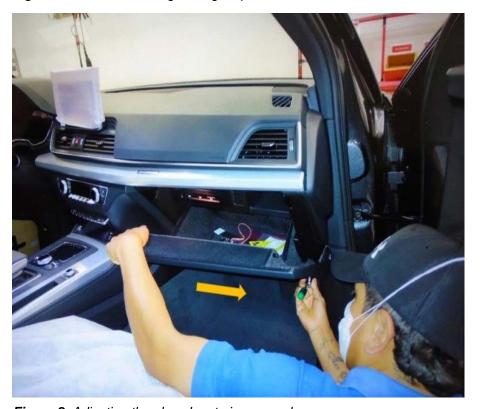
Figure 2. Adjusting the glove box to increase clearances.

• The gap between the center console and the glove box door is insufficient.

While pulling the glove box door outward in direction of the A-Pillar, tighten the glove box bolts according to the sequence outlined in this TSB (Figure 1, Figure 2).
