Technical Service Bulletin

68 Noises from dash panel and/or center console

68 20 27 2061594/1 December 7, 2020.

Model(s)	Year	VIN Range	Vehicle-Specific Equipment
Audi e-tron quattro, Audi e-tron Sportback	2020	All	Not Applicable
Audi e-tron quattro, Audi e-tron Sportback	2021	000001 - 011840	Not Applicable

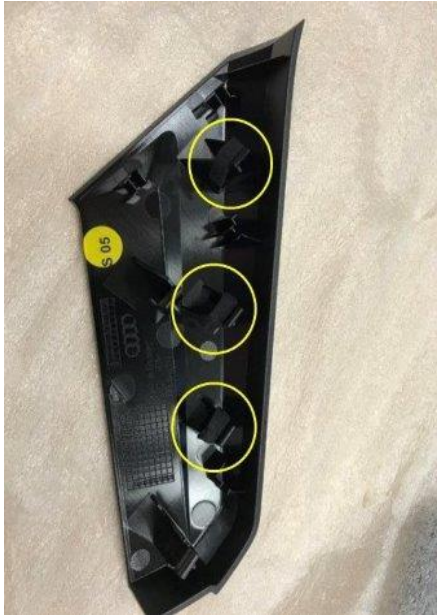
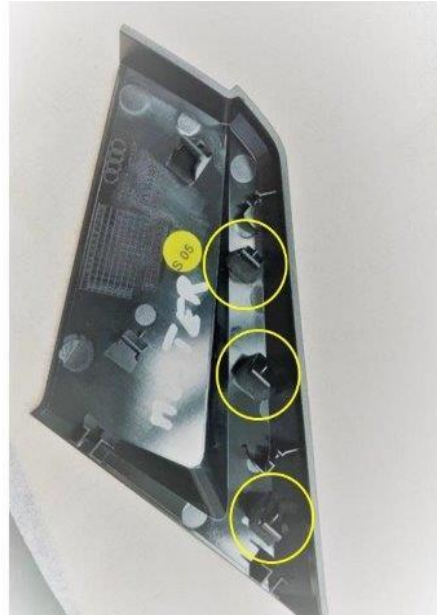
1. Front AC display (lower MMI screen) to AC display close out trim panels.
2. Upper MMI screen to MMI screen mounting bracket in the instrument panel.

Figure 1. Felt tape applied to the mounting tabs.

Figure 2. Felt tape applied to the mounting tabs.

1. Remove both front AC display close out trim panels according to the repair manual.
2. Apply 6 pieces of felt tape to the mounting tabs of the air conditioning trim panels (Figures 1 and 2). Adding felt tape will increase the gap between the trim panels and the AC display.

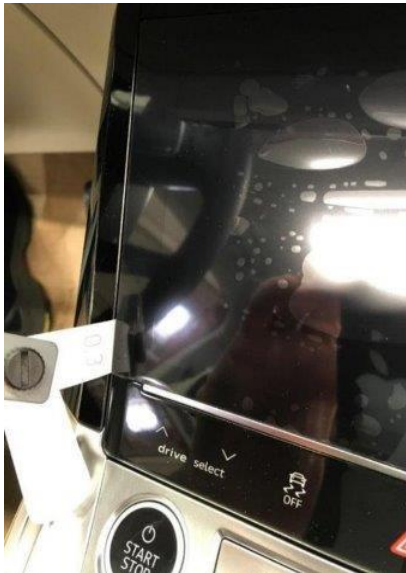
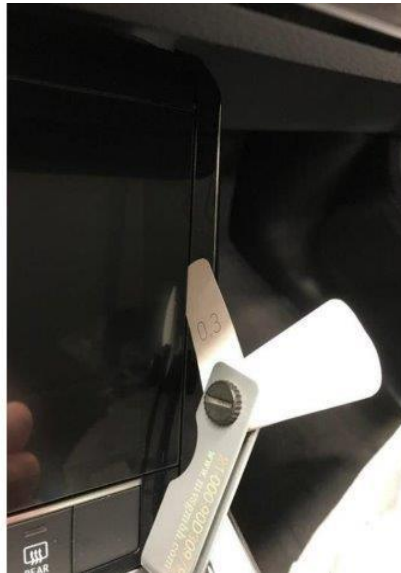
Figure 3. 0.3 mm gap after the repair.

Figure 4. 0.3 mm gap after the repair.

3. Reinstall both close out trim panels according to the repair manual.
4. Check the gap between the front AC display and the closeout trim panels on both sides to ensure a gap of 0.3 mm (Figures 3 and 4).

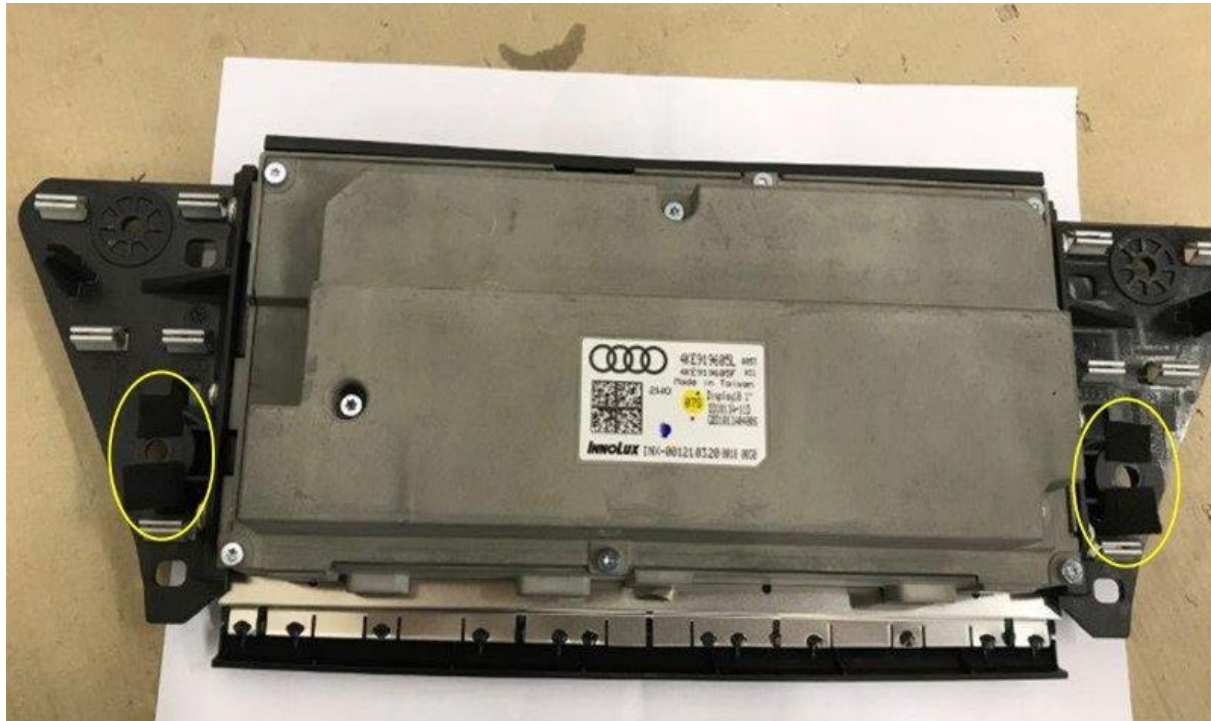
Figure 5. Felt tape applied to the back of the upper MMI screen.

1. Remove the upper MMI screen according to the repair manual.
2. Apply four pieces of felt tape to the back of the MMI screen (Figure 5).
