Technical Service Bulletin

87 Air conditioning does not cool, DTC B16A284 is stored in the thermal management control module

87 20 12 2061660/1 December 15, 2020.

Model(s)	Year	VIN Range	Vehicle-Specific Equipment
A8, S8	2020 - 2021	All	Not Applicable

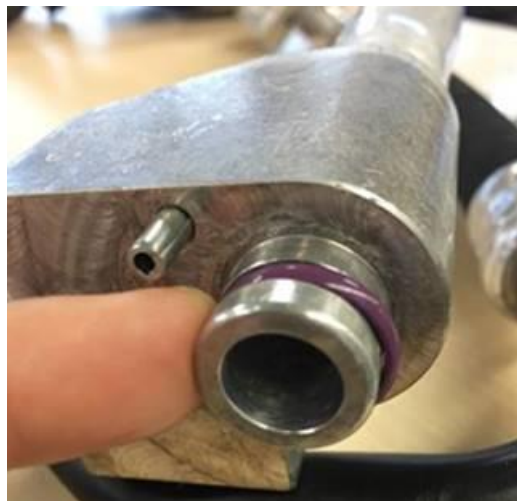
A refrigerant leak test reveals a leak at the bolted connections of the refrigerant line with inner heat exchanger that connects the main circuit to the rear evaporator. When the line is removed an incorrect and/or damaged O-ring seal is found (Figure 1).

Figure 1. Damaged refrigerant line O-ring seal.

1. Perform an air conditioning circuit leak test diagnosis using either contrast dye or by pressurizing the circuit with compressed nitrogen and investigating the leak location with a soapy water solution at each end of this refrigerant line. Provided no damage to the mating sections of the line are found replace the O-ring seals on either end of the line. If a leak is not found at either end of this refrigerant line, continue with the leak diagnosis and repair.
2. Please take photos of the customer concern and upload them into DOC-IT with the repair order. Photos should:
 - Have a date stamp and VIN reference.
 - Be taken in focus and with sufficient light.
 - Where it is appropriate, mark the affected place for a reference to the concern for analysis.

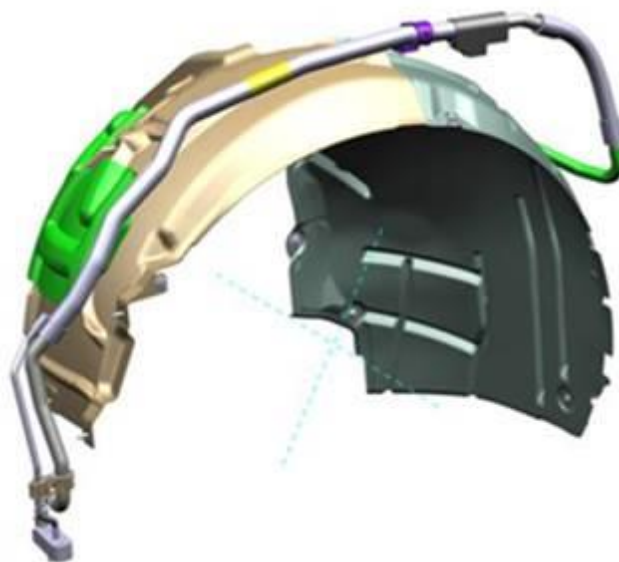
The refrigerant line with inner heat exchanger is located inside the left front wheel housing liner (Figure 2).

Figure 2. Location of the refrigerant line with inner heat exchanger that connects the main refrigerant circuit to the rear evaporator
