90 Instrument cluster digital speed display is shown off-center

90 20 81 2057479/2 December 9, 2020. Supersedes Technical Service Bulletin Group 90 number 19-32 dated November 26, 2019 for reasons listed below.

Model(s)	Year	VIN Range	Vehicle-Specific Equipment
Q8	2019	All	Audi virtual cockpit

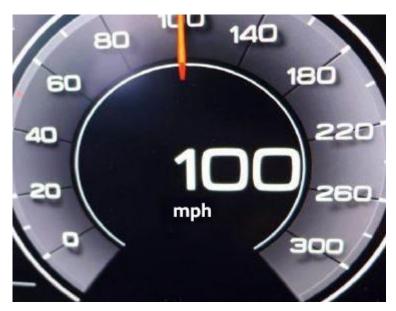
The digital speed display in the Audi virtual cockpit is shown off-center to the right (Figure 1).

Figure 1. Off-center speed display in the Audi virtual cockpit.

The software of the instrument cluster needs to be updated.

• Update the instrument cluster using either Method 1 or Method 2 according to TSB 2056558: *91 MIB2+Software Update Instructions* and use SVM code FPKWW0156.
