Technical Service Bulletin

90 Audi virtual cockpit center display is black

90 20 84 2059568/2 December 18, 2020. Supersedes Technical Service Bulletin Group 90 number 20-47 dated May 20, 2020 for reasons listed below.

Model(s)	Year	VIN Range	Vehicle-Specific Equipment
Q3	2019	All	Audi virtual cockpit plus
Q3	2020	000001 - 000731	Audi virtual cockpit plus

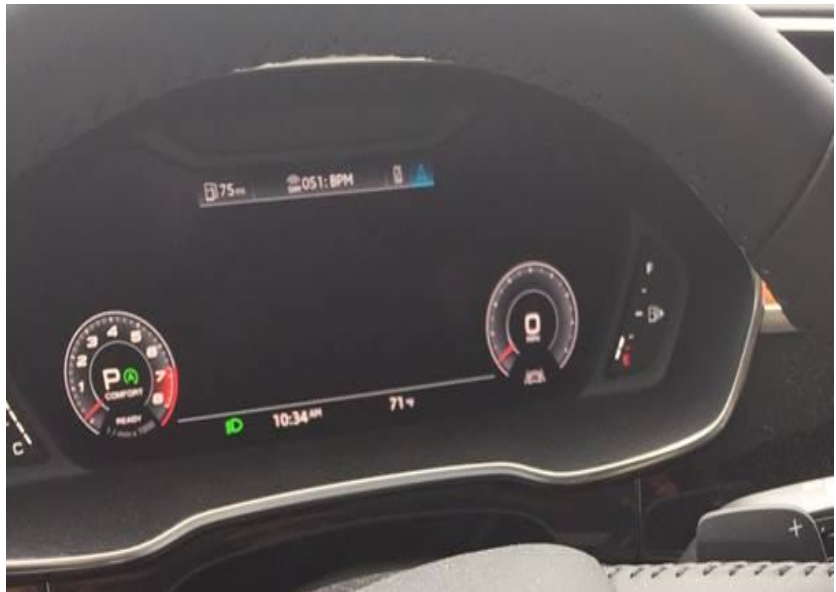
- The center display in the Audi virtual cockpit is black and does not show the expected tab (Figure 1). It is not relevant which tab the Audi virtual cockpit currently displays (on-board computer, infotainment, phone, and navigation).

Figure 1. The center display in Audi virtual cockpit is black.

A software bug can cause the center display to sometimes become black.

New software in the instrument cluster control module, J285 (address word 0017) addressed the condition.

1. Follow all instructions in TSB 2011732: *00 Software Version Management (SVM), operating instructions* and TSB 2047812: *00 SD Creator: how to set up and use the SD Creator for obtaining vehicle software updates via the MirrorServer*.
2. Update the instrument cluster control module, J285 (address word 0017) using the SVM action code and instructions as listed in the table below:

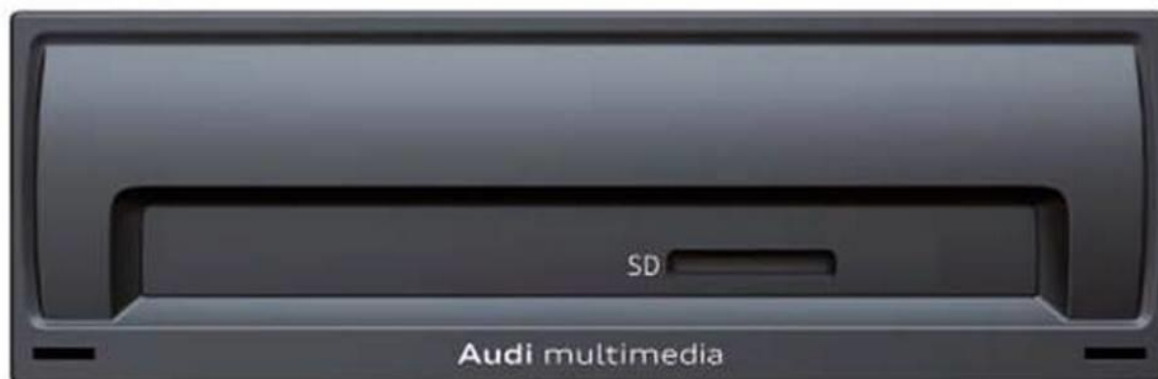
Figure 2. An infotainment control module (example).

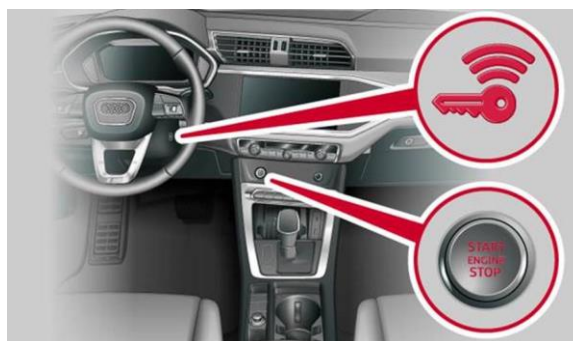
Figure 3. A steering column with mark for the vehicle key.

6. If the message: "...hold the vehicle key on the transponder..." appears, hold the vehicle key to the marked location on the steering column (Figure 3) until the update is completed.

Tip: It is recommended to affix the vehicle key in this position with an adhesive tape that can be removed without leaving any residue.
