Technical Service Bulletin

91 Google Earth is greyed out or does not function in the MMI with a warning, "The subscription has expired"

91 20 41 2060681/2 December 1, 2020. Supersedes Technical Service Bulletin Group 91 number 20-23 dated October 22, 2020 for reasons listed below.

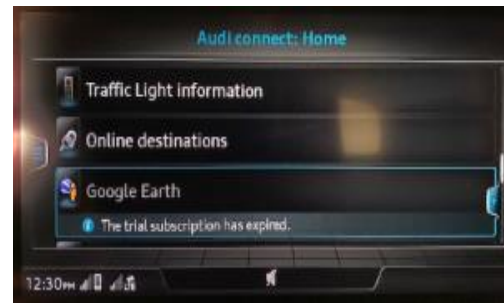
- The Google Earth option in the MMI is greyed out (Figure 1), or there is an error when starting the service that states, "The subscription has expired."
- The customer must have an active Audi connect PRIME subscription (check: www.myaudiconnect.com).

Figure 1. Google Earth is greyed out.
