Technical Service Bulletin

91 Sound system: A-pillar speaker rattle, vibration or poor audio reproduction

91 20 45 2059143/2 December 16, 2020. Supersedes Technical Service Bulletin Group 91 number 20-55 dated April 8, 2020 for reasons listed below.

Model(s)	Year	VIN Range	Vehicle-Specific Equipment
A6, A7	2019	All	Not Applicable

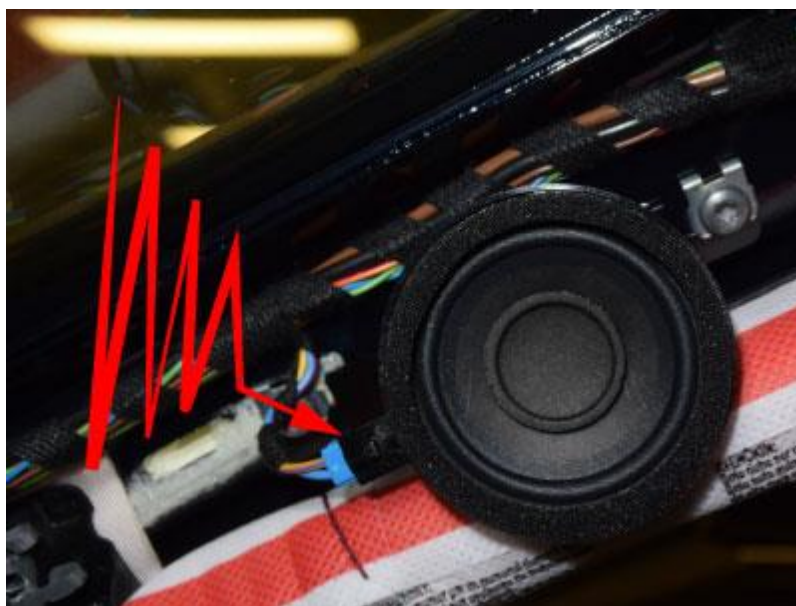
Tolerance between the speaker and harness connector is too high, creating unwanted vibration.

1. Verify that the noise is coming from the electrical connector at the A-pillar speaker (R276 or R277) (Figure 1).

Figure 1. Unwanted noise at the A-pillar speaker's electrical connection.

2. Ensure fasteners are properly torqued to 3.0Nm.
3. Replace the connector at the speaker with the improved connector 4B0 971 832 A.
