Technical Service Bulletin

91 MIB2+: lower display flickering after a software update

91 20 47 2061029/3 December 17, 2020. Supersedes Technical Service Bulletin Group 91 number 20-37 dated November 17, 2020 for reasons listed below.

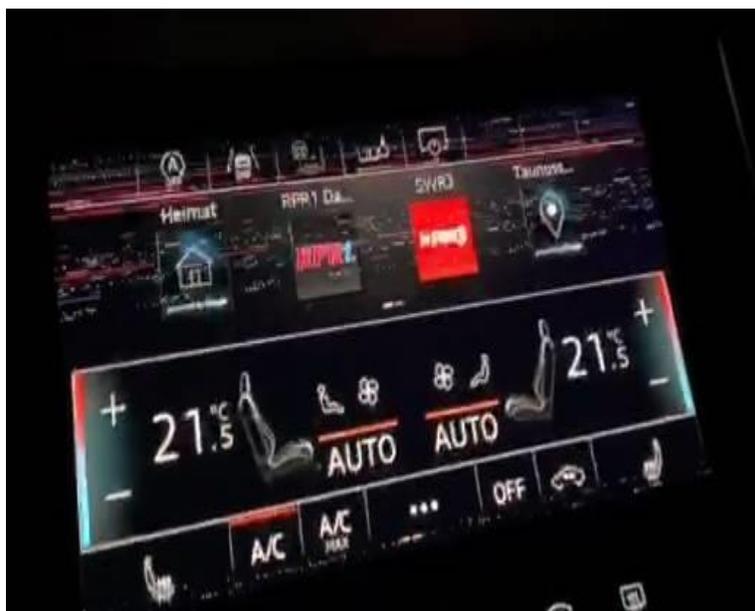
- After a MMI Software update has been completed, the lower display sporadically flickers (Figure 1).

Figure 1. The display sporadically flickers.

There are compatibility issue between the display and MMI software.

- Update the MIB2+ display using either Method 1 or Method 2 according to TSB 2056558: *91 MIB2+ Software Update Instructions* and use SVM code 636S002.
