Technical Service Bulletin

91 Audi Smartphone Interface (ASI): Apple CarPlay or Android Auto display screen intermittently goes blank in FPK

91 20 48 2060264/3 December 17, 2020. Supersedes Technical Service Bulletin Group 91 number 20-96 dated August 21, 2020 for reasons listed below.

Model(s)	Year	VIN Range	Vehicle-Specific Equipment
R8, TT, and TTRS	2018 - 2020	All	Not Applicable

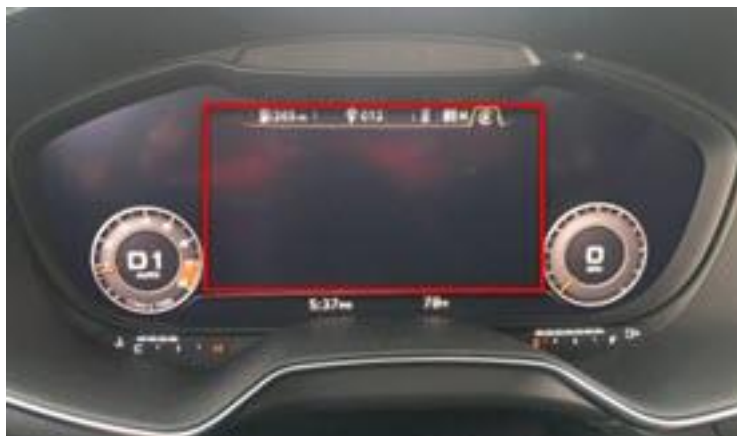
- The FPK (Free-Programmable Kombi/Cluster) screen goes blank intermittently when viewing the Audi Smartphone Interface (ASI) screen (Figure 1).
- This can occur while using Apple CarPlay or Android Auto.

Figure 1. FPK screen is blank.

This condition is caused by an MMI software configuration issue. Model Year 2019-2020 vehicles can have this issue with the factory-installed MMI software. Additionally, Model Year 2018 vehicles that received a recent MMI

software update could also experience this issue. It's important to note that the issue is intermittent and does not always occur during a drive based on driving conditions. However, for some customers, this issue can occur during each trip each day.

1. Follow all instructions in TSB 2047576: *91 MIB2 High Navigation Software Update Instructions (PR Code 7UG).*
2. Update the infotainment system using the SVM action code and SD-Card as listed in the table below, if necessary:
