Technical Service Bulletin

91 MIB2 High Navigation Software Update Instructions (PR Code 7UG)

91 20 50 2047576/5 December 17, 2020. Supersedes Technical Service Bulletin Group 91 number 20-89 dated July 24, 2020 for reasons listed below.

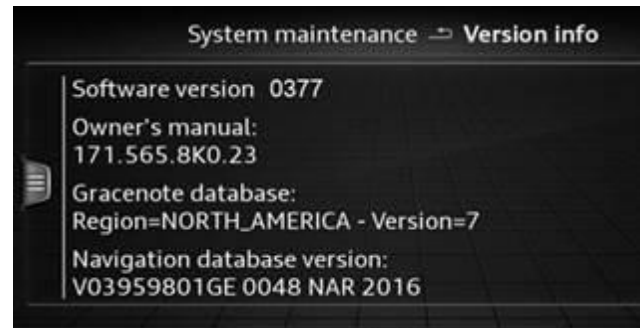
1. To save time, always verify the customer's MMI requires the software update before proceeding. In the MMI, go to *Menu >> Settings >> Left drawer option >> Version Information* (Figure 1). This applies to models using the new MIB2 user interface. The C7 PA uses the old user interface similar to MMI3G+ along with the newer MIB2 hardware. The software version for the older user interface is found under *Menu >> Setup MMI >> Version Information*.

Figure 1. MIB2 Software Version in MMI with a new UI.
