## Volvo Chassis - Heating/Air Conditioning System (HVAC) Whistle From Vents At Highway Speeds - Build Date 1 January 2018 And Newer

Volvo chassis built with after 1 January 2018 may experience a whistling noise from the vents in the dashboard at highway speeds (over 50 mph/80 kph) when the recirculation door is closed and blower fan speed on low or medium. This believed to be caused by an air gap between the recirculation door center HVAC mullion.

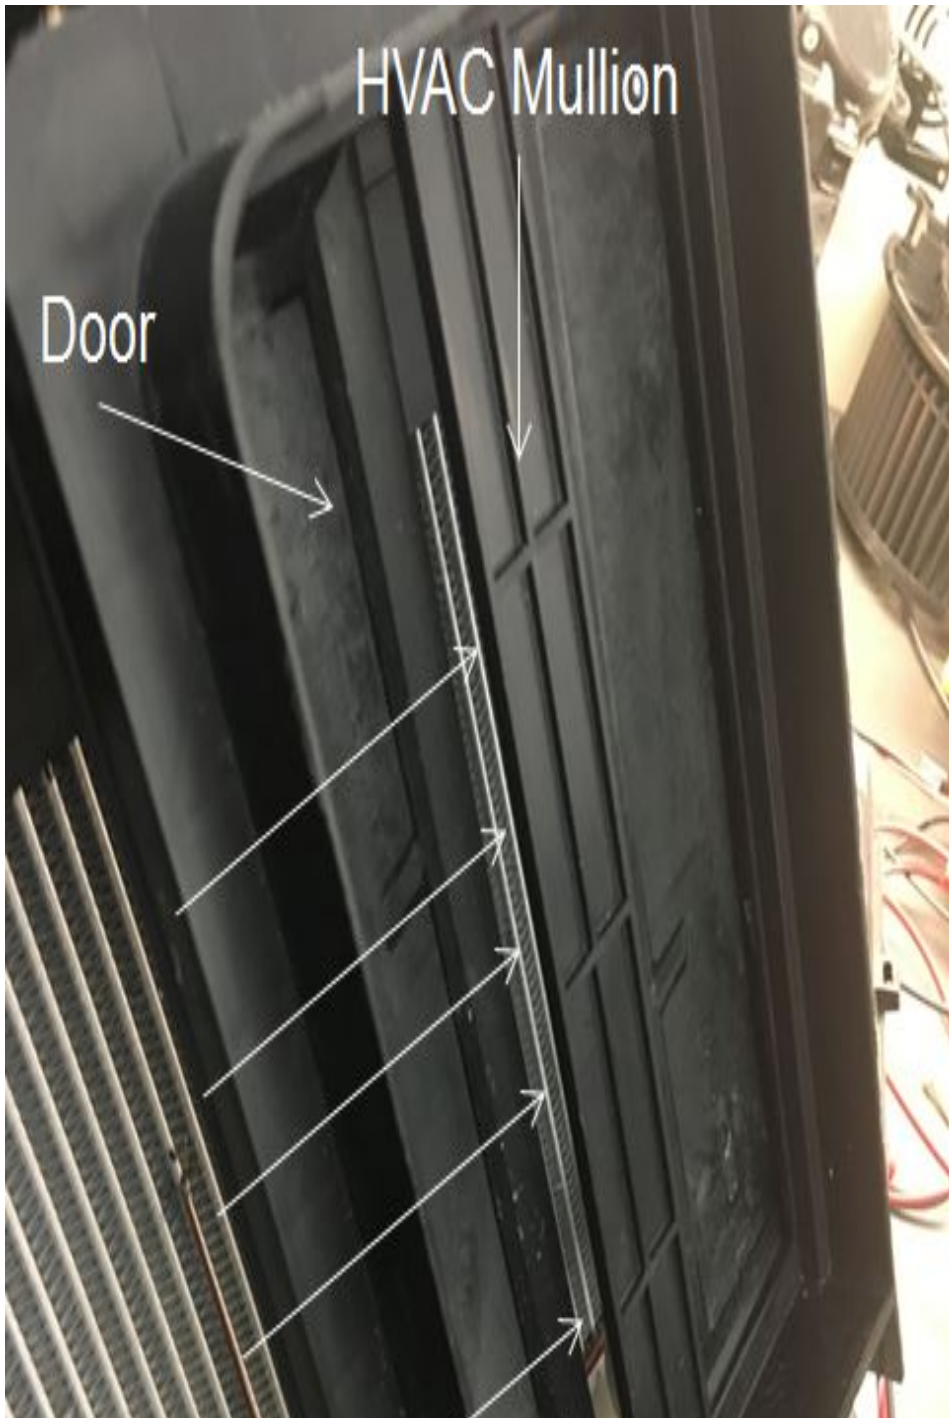
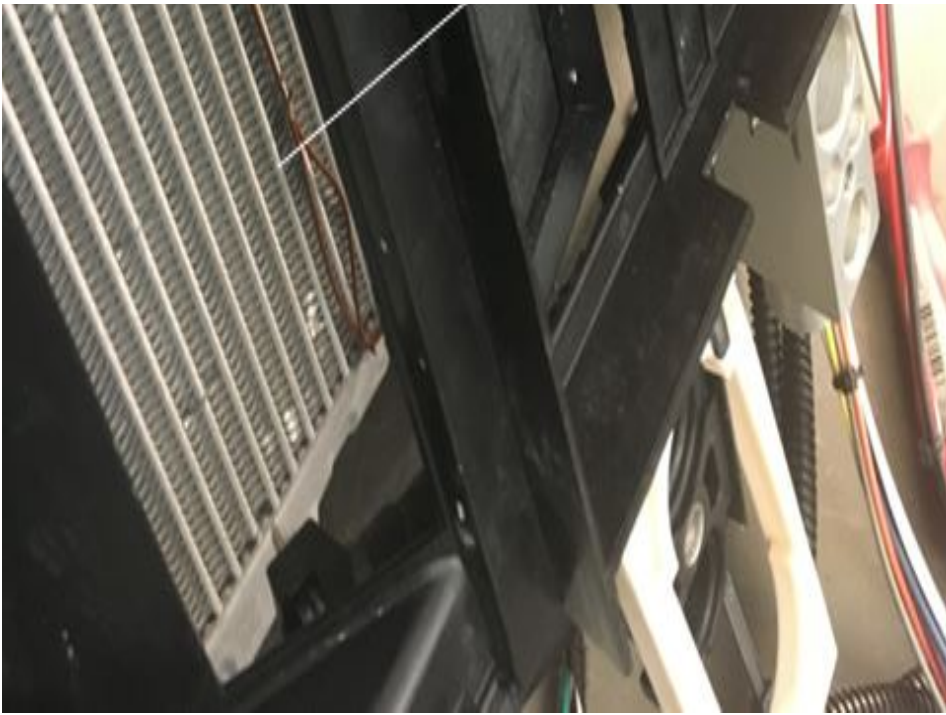
The gap shown in the picture above is enlarged for clarity. Note that the evaporator core can be seen through the gap.

1. Remove the fresh air intake from the vehicle to gain access to the recirculation door area from outside of the vehicle.
2. Apply a thin layer of white lithium grease to all sealing surfaces between the door and the HVAC mullion (refer to the picture above).
3. Reinstall the fresh air intake when modification of the door seal is complete.

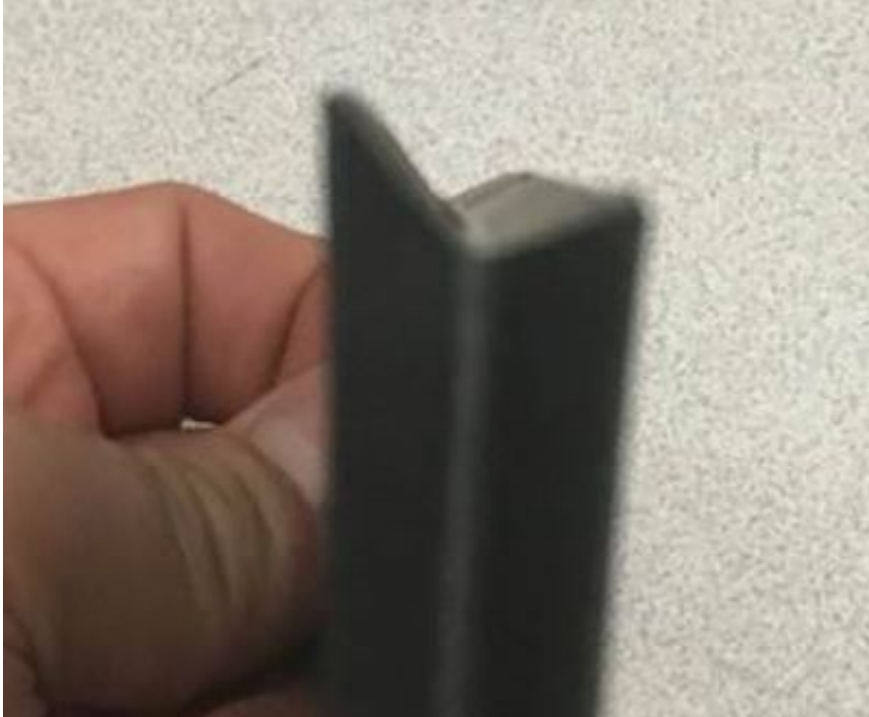
- The seal is a "V" shape and it is possible to remove only one side of the seal. See the picture below.

**2.** Using the photos below as a guide, cut off the section of the recirculation door seal that covers the opening when the HVAC system is set to recirculation.

- Both doors CAN have the overmold seal cut back as shown. However one should be sufficient.
