## **Volvo Chassis - Transmission Harness Wrap Failure Causing open- or short-circuits and datalink fault codes**

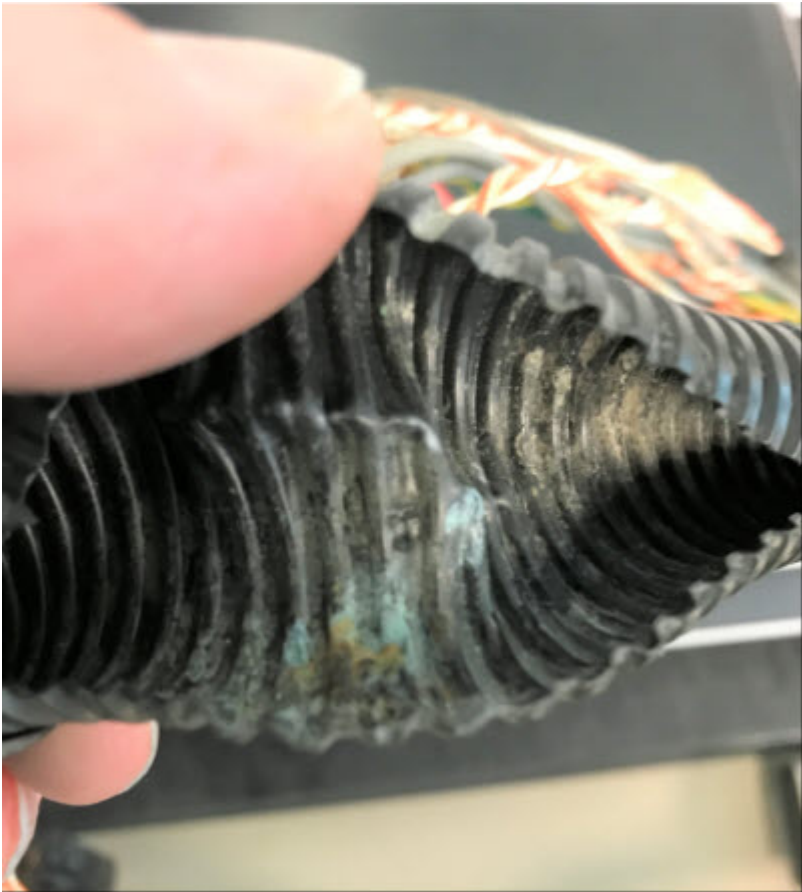
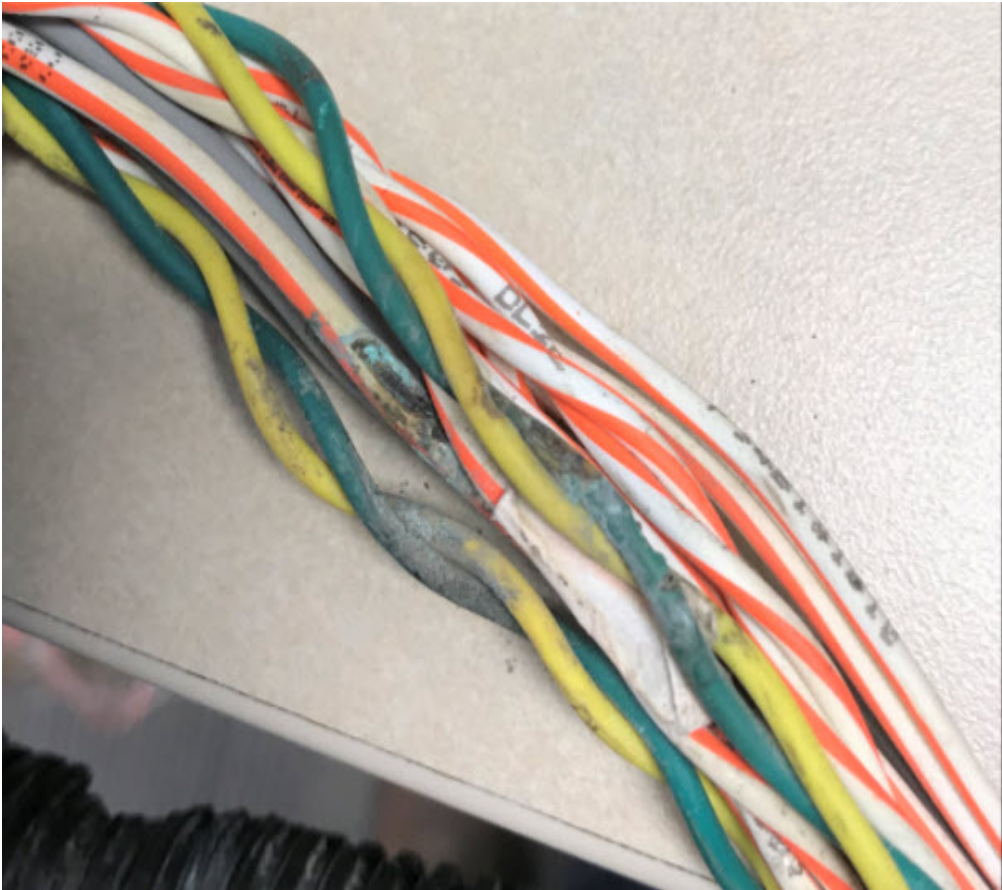
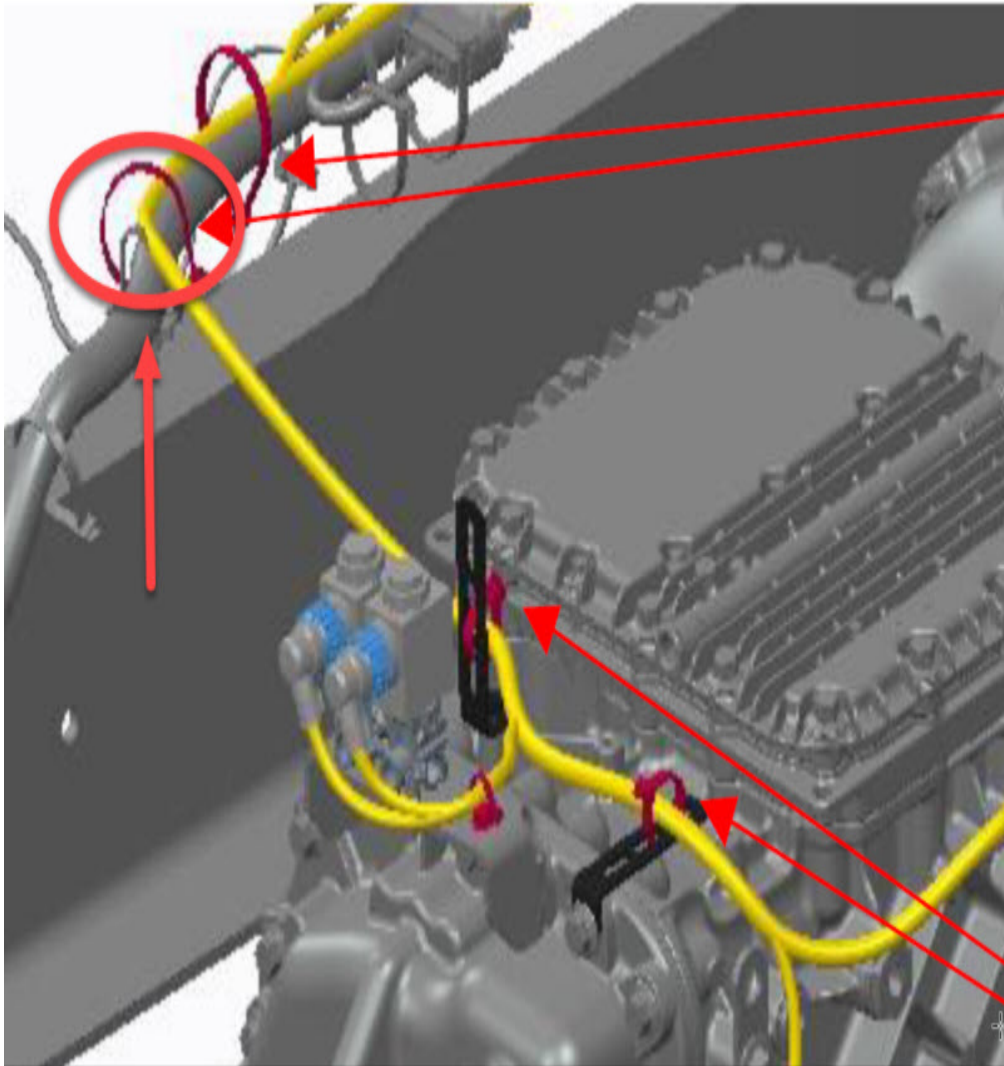
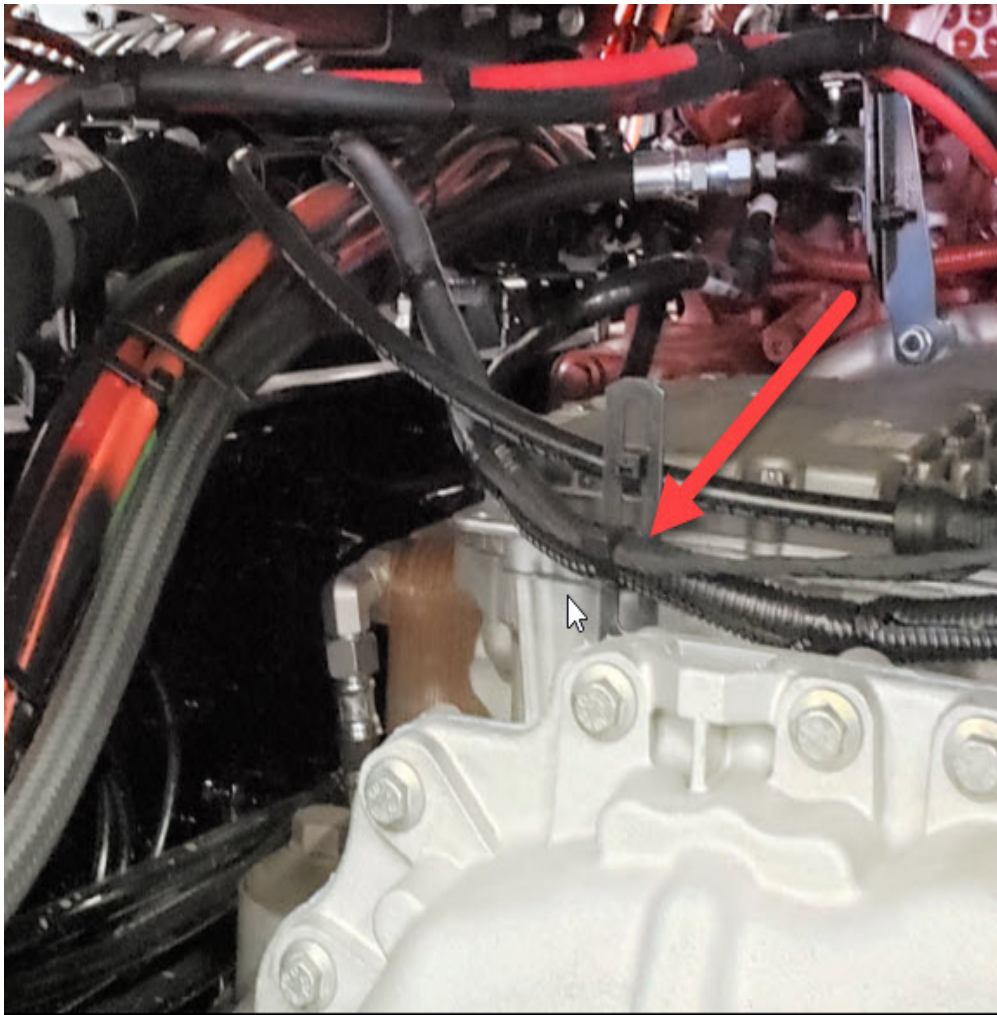
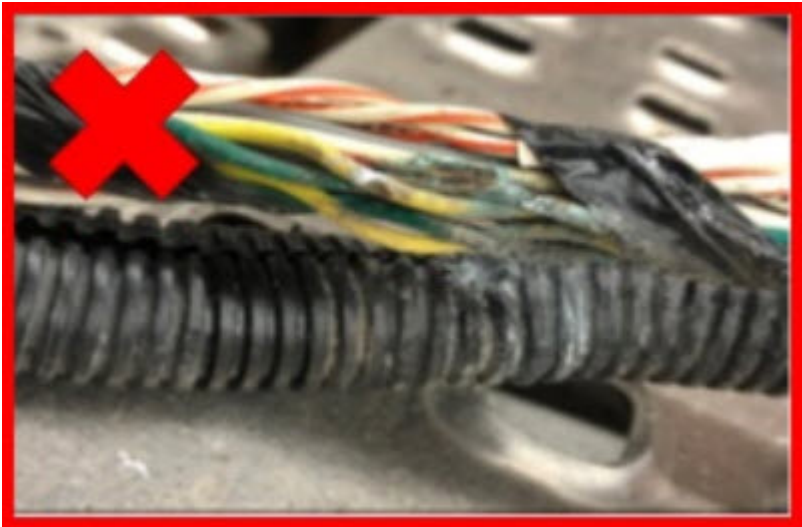
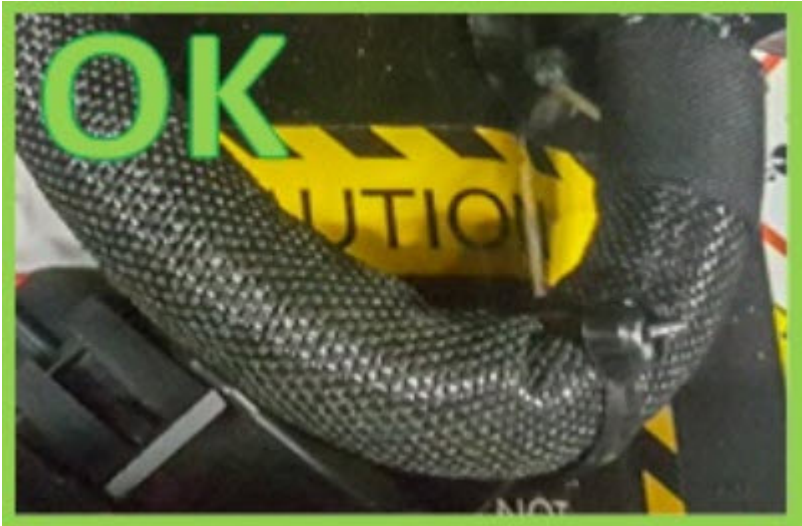
Some Volvo trucks, built April 25, 2016 - September 25, 2020, with AMT-F iShift transmissions were built with transmission harnesses that used split convoluted tubing. Split convoluted tubing can damage wiring insulation which can lead to open- or short-circuits and datalink fault codes. Updated transmission harnesses are available that use woven cloth tape and heavy duty wrap to protect the wiring from damage. See illustrations below.

| Updated Transmission Harness Part Number | |
| Without crawler gears | 23917360 |
| With crawler gears | 23917358 |
