## Mack Chassis - Transmission Harness Wrap Failure Causing Open Or Short Circuits, Possible Datalink Fault Codes

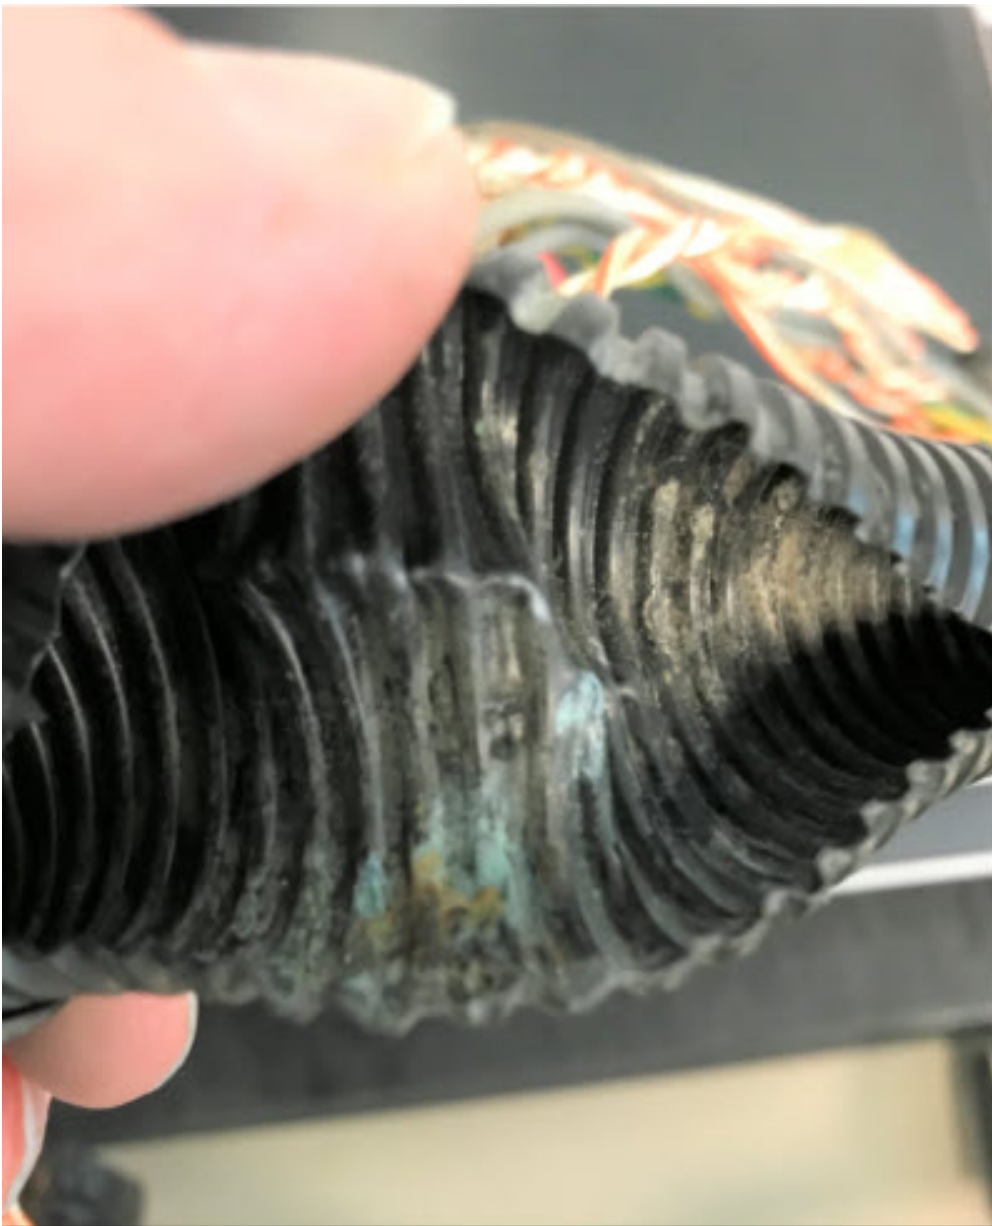
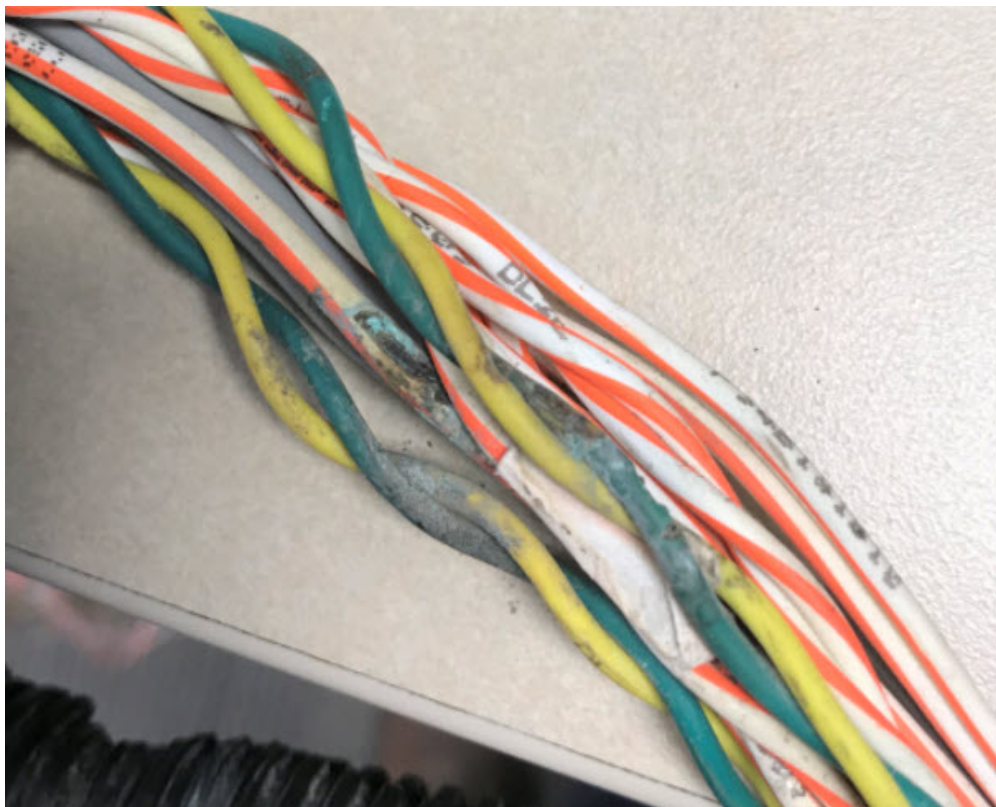
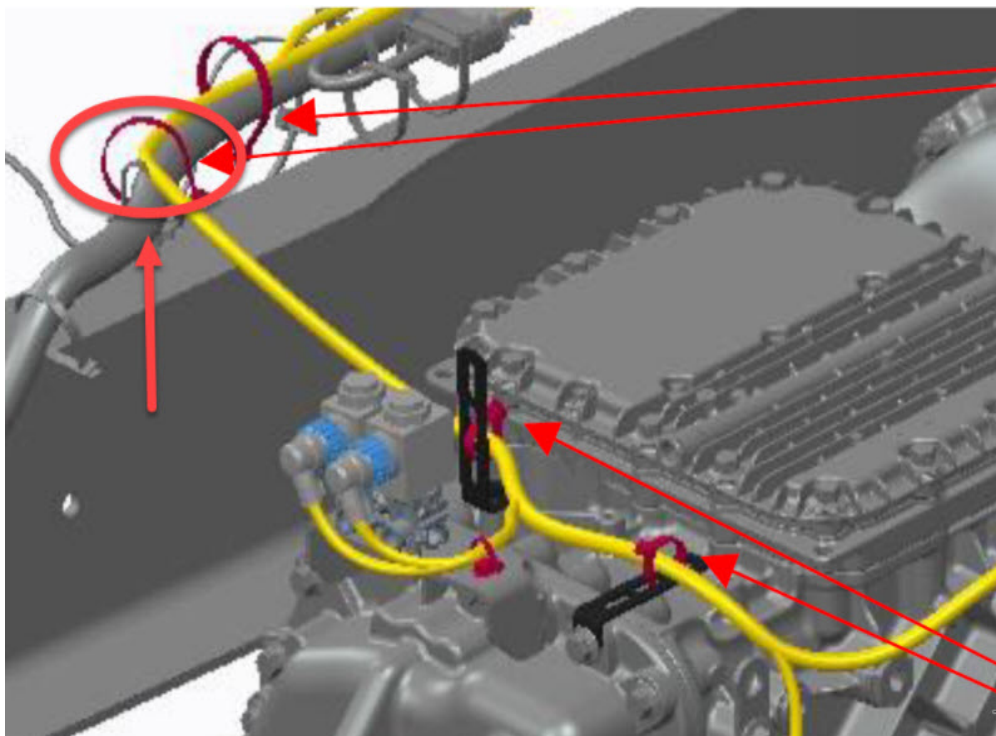
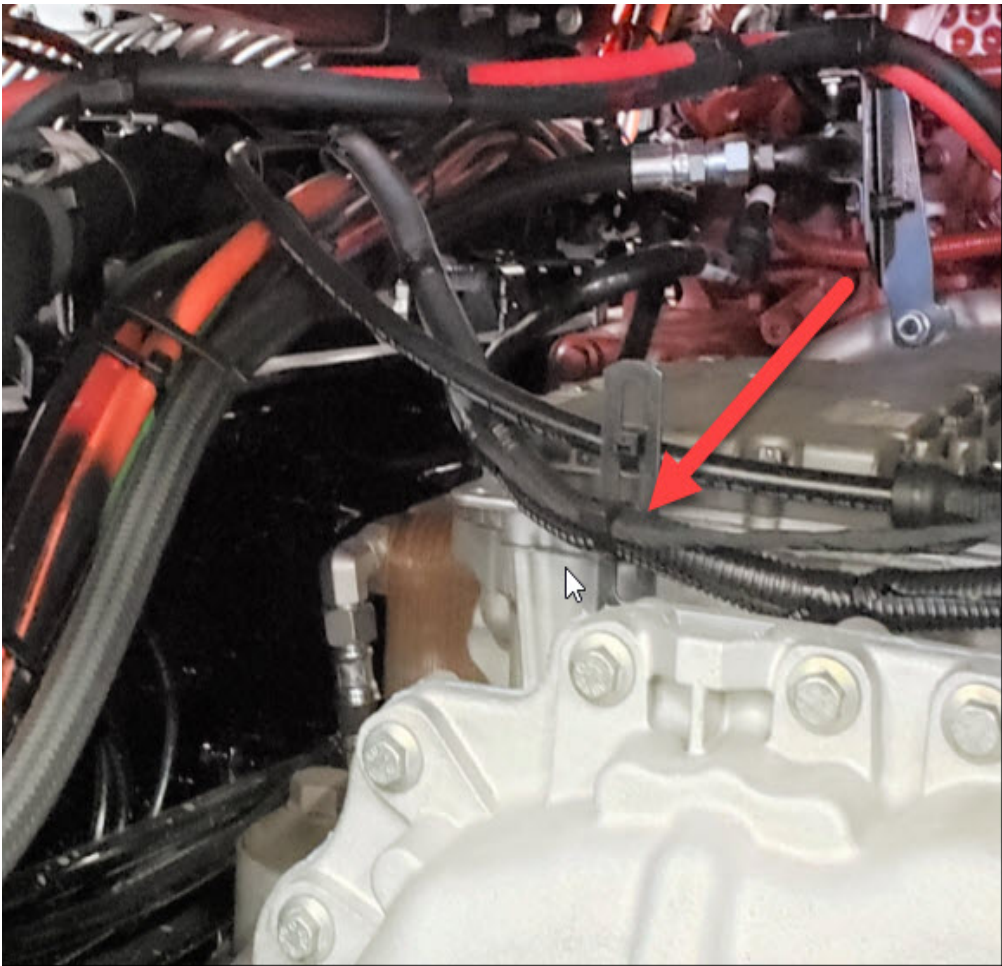
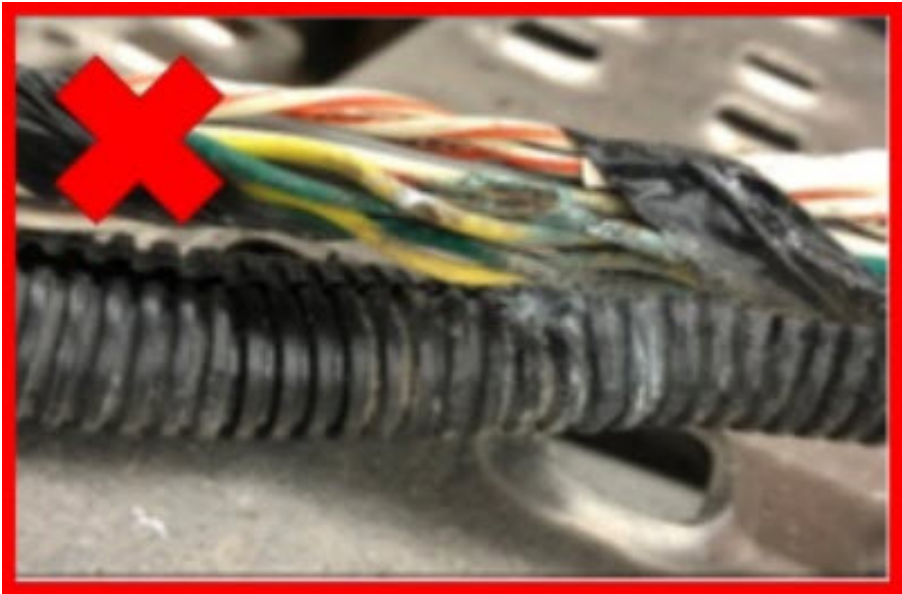
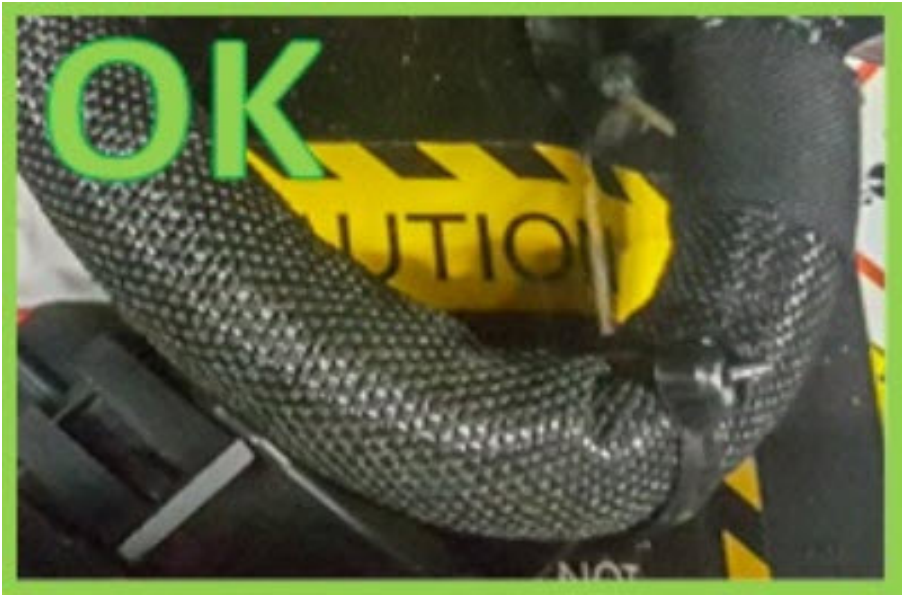
Vehicles built between 26 September 2016 and 25 September 2020 with AMT-F (mDrive) transmissions may have been assembled with transmission harnesses that were wrapped with split convoluted tubing. Split convoluted tubing in this application can damage wiring insulation which can lead to open or short circuits and datalink fault codes.

Updated transmission harnesses are available that use woven cloth tape and heavy duty wrap to protect the wiring from damage. See illustrations below.
