JTBO0579NAS2

TECHNICAL BULLETIN

16 DEC 2020

Transmission Electrical Wiring Harness Chafing on Rear Driveshaft

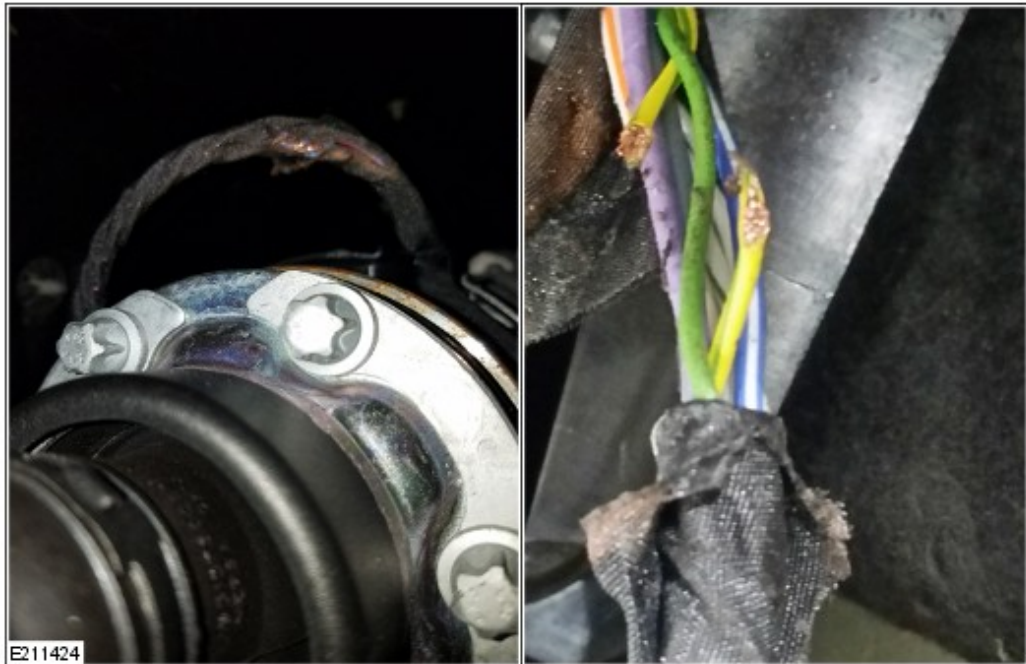
1.

The illustration shows an example of the possible damage to the transmission electrical wiring harness.

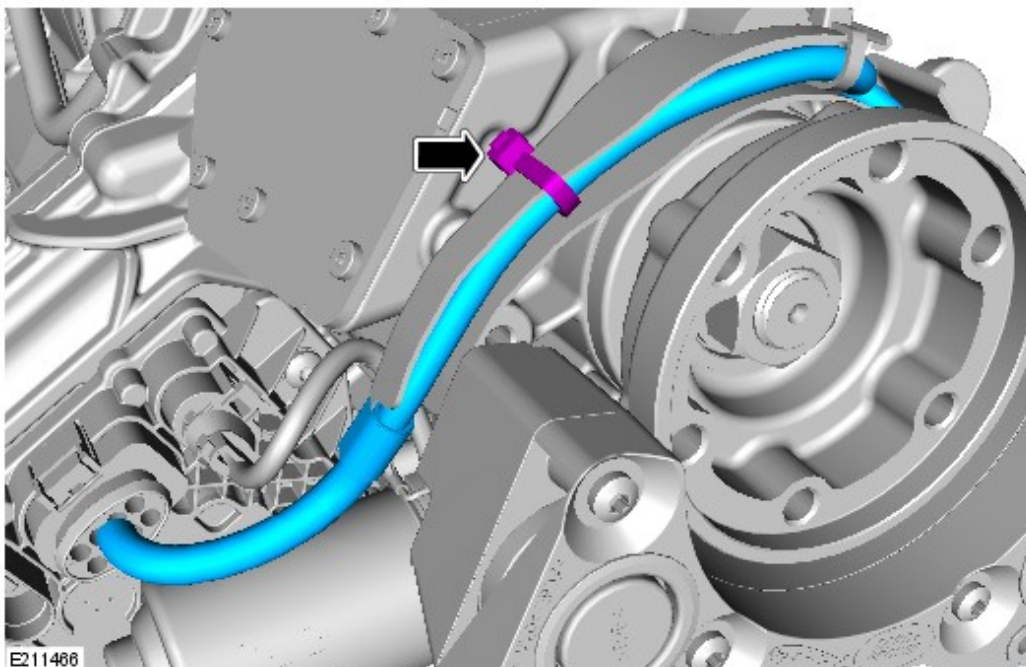
2.

A missing cable tie on the transmission electrical wiring harness on All Wheel Drive (AWD) vehicles.

The illustration shows the cable tie that is missing on the transmission electrical wiring harness.
